# The Study of Fatigue Life Discrepancy on High-Strength Steel Springs Used in Automotive Engine Application

THESIS PRESENTED TO ÉCOLE DE TECHNOLOGIE SUPÉRIEURE IN  
PARTIAL FULFILLMENT FOR A MASTER'S DEGREE WITH THESIS IN  
MECHANICAL ENGINEERING  
M.A.Sc.

MONTREAL, DECEMBER 21, 2016

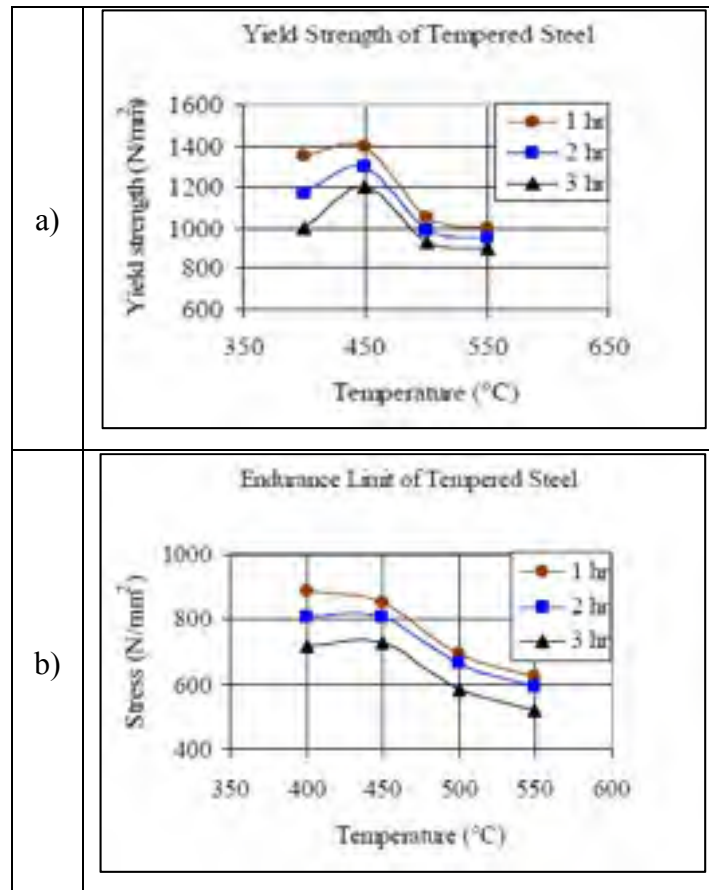
Figure 1.1 Show the yield strength (a) and endurance limit (b) of high-strength steels in different tempering temperatures and holding times, the figure reported from Htun, Kyaw and Lwin (2008).

Recent studies show that high-strength steels with mixed bainitic-martensitic structures have better mechanical properties than steels with tempered martensite structures. For instance, Htun, Kyaw and Lwin (2008) have shown that mixed bainitic-martensitic steels after tempering at 450 °C for 1 hour have maximum yield strength and endurance limit. Figure 1.1 (a) shows high-strength steels after tempering at 450 °C for 1 hour have maximum yield strength. These authors have proved that mixed bainitic-martensitic structures, after 1-hour tempering at 400 °C to 450 °C have the maximum endurance limit (Figure 1.1 (b)).

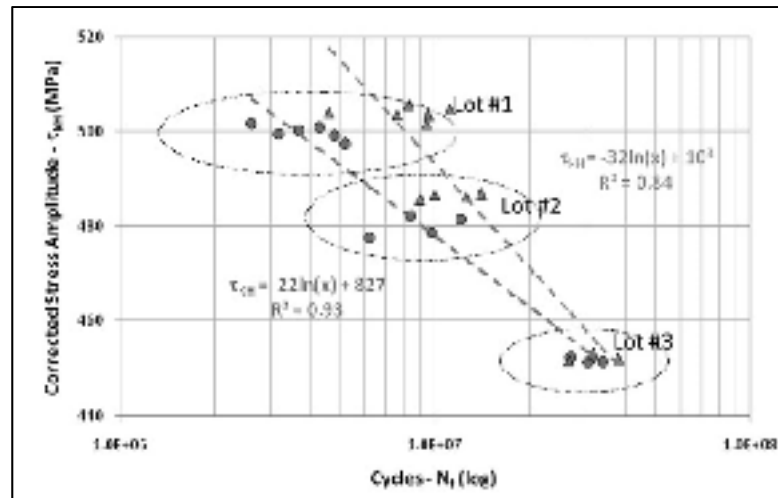
Figure 1.2 Comparison of the fatigue lives at different stress level for the bainitic-martensitic steels (▲) and martensitic steels (●), figure reported from Serbino and Tschiptschin (2014).

Serbino and Tschiptschin (2014) have shown that bainitic-martensitic steels have higher fatigue life at stress amplitude of 500 MPa compare to tempered martensite (Figure 1.2). However, at lower stress amplitude (450 MPa and 475 MPa) fatigue lives of both steels were almost similar.

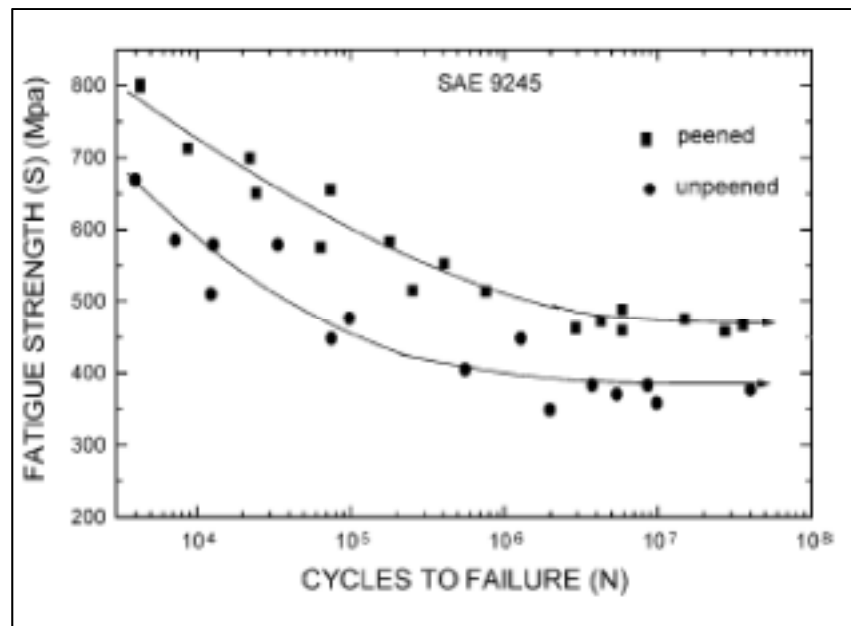
Figure 1.6 S-N curve for shot peened and unpeened specimens, figure reported from (Tekeli, 2002)

While single shot peening with very big shot size induces good depth of compressive residual stress and improves the fatigue life (Figure 1.6) (Tekeli, 2002) but shot peening in high peening intensity and big shot size create lots of surface damages causing early crack nucleation as damage can be induced by the process itself (Vielma, Llaneza and Belzunce, 2014). Figure 1.7 shows an example of surface damages after shot peening with big shot sizes.

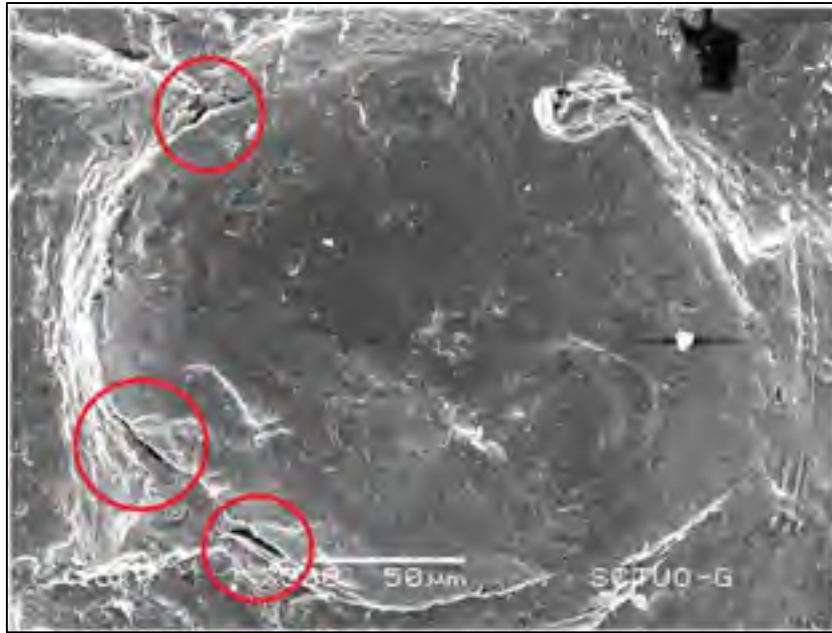
Figure 1.7 Surface damages due to the shot peening with big shot size. Red circles show the surface damages around the shot impact, reported from (Vielma, Llaneza and Belzunce, 2014).

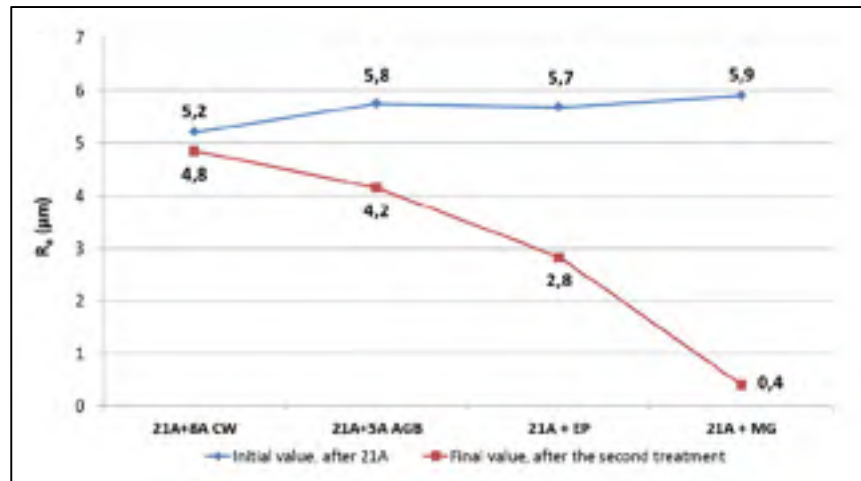
Figure 1.8 Roughness evolution after second surface treatments, figure reported from (Vielma, Llaneza and Belzunce, 2014).

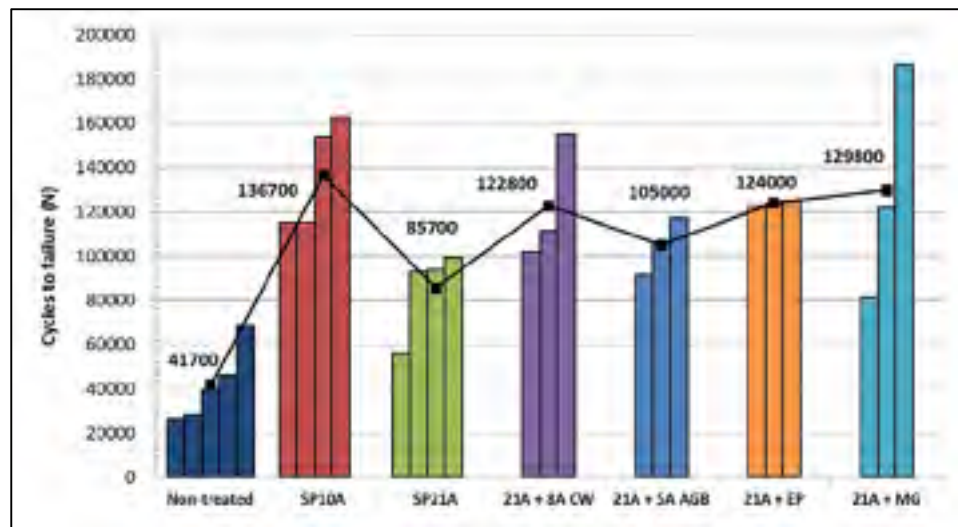
Figure 1.9 Fatigue lives of the steels with different surface treatments. Testing stress = 50% of the tensile strength of the steels, figure reported from (Vielma, Llaneza and Belzunce, 2014).

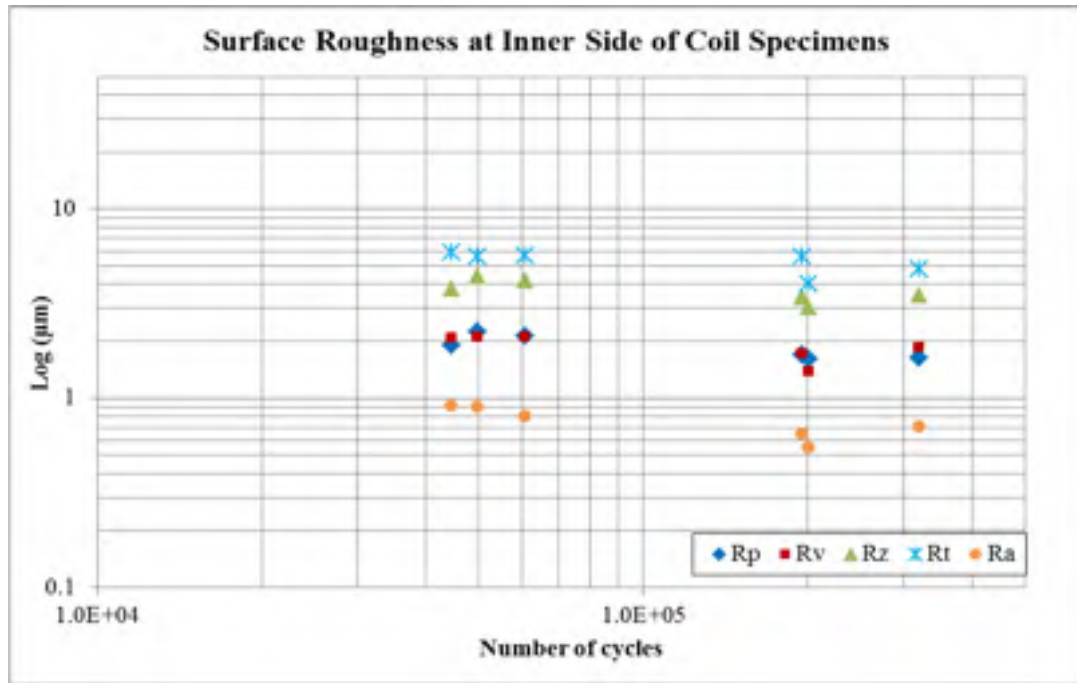
Figure 3.4 Surface roughness comparison for coil specimens in logarithmic scale.

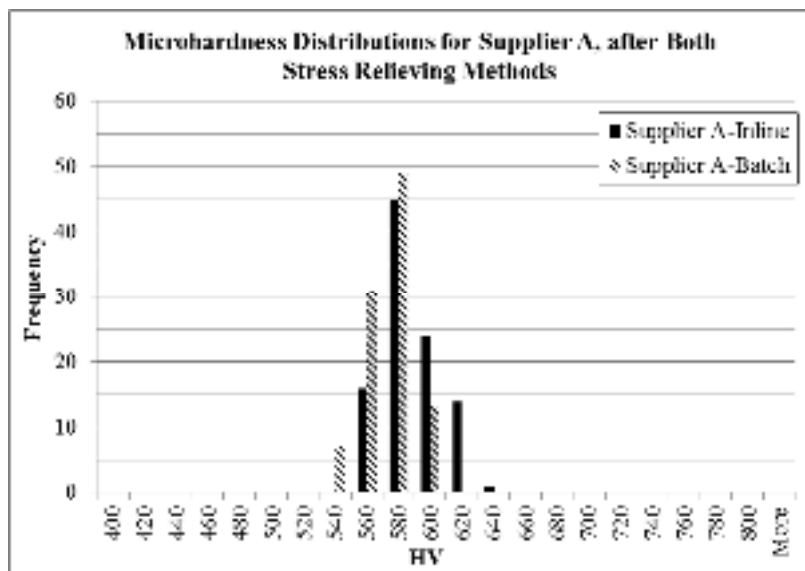
Figure 3.10 Showing the microhardness distributions of supplier A products after stress relieving with batch and inline methods.

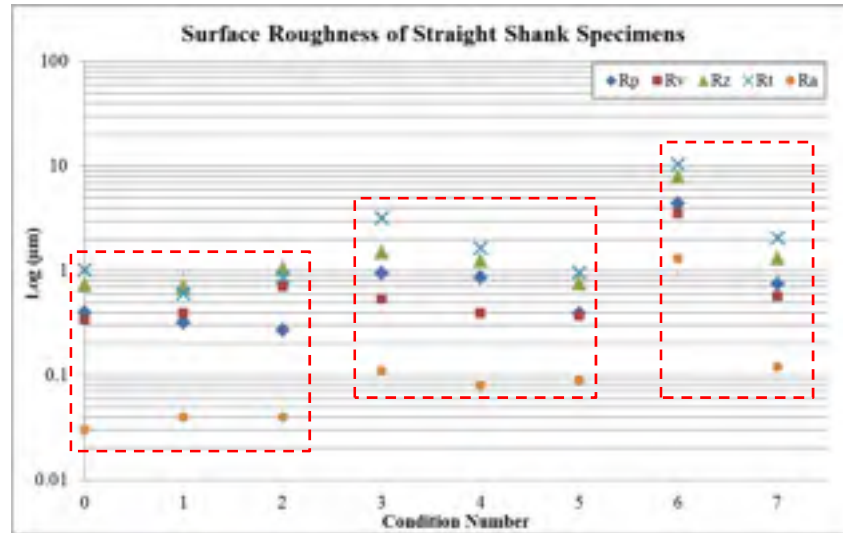
Figure 3.14 Surface roughness values in logarithmic scale for different conditions of straight shank specimens (Table 3.1).

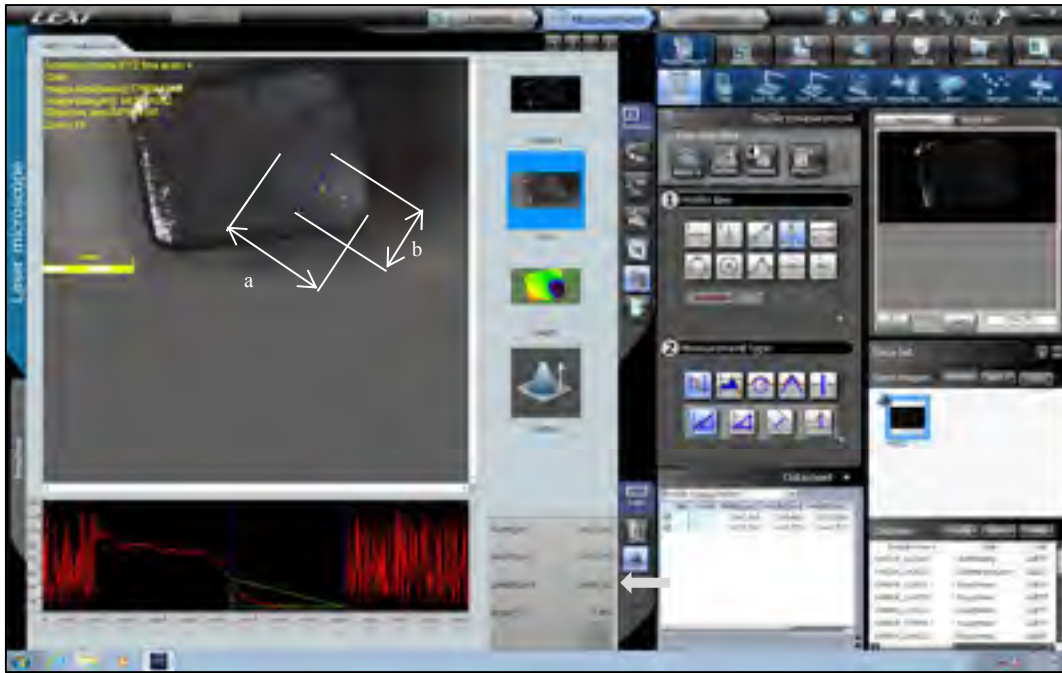
Figure-A I-1 Propagation ellipse measurements for specimen failed at 44552 cycles.
