THÈSE PAR ARTICLES PRÉSENTÉE À
L'ÉCOLE DE TECHNOLOGIE SUPÉRIEURE

COMME EXIGENCE PARTIELLE
À L'OBTENTION DU
DOCTORAT EN GÉNIE
Ph. D.

ÉTUDE DES FACTEURS INFLUENÇANT LE MÉCANISME DES DÉCHARGES
PARTIELLES D'ENCOCHE

MONTREAL, LE 7 AOÛT 2012

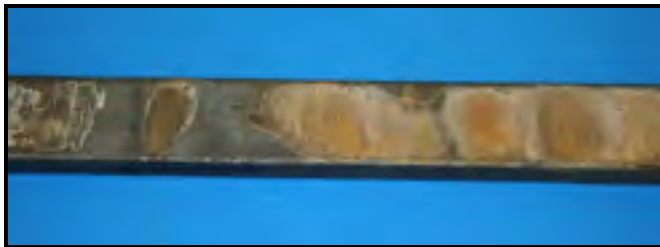
des DP intenses dites DP d'encoche peuvent se produire dans l'air entre la surface du revêtement semi-conducteur et le noyau magnétique. Si le revêtement semi-conducteur est trop conducteur et qu'il y a des pertes de contact avec le noyau magnétique, la circulation d'un courant intense peut générer des étincelles ou décharges de courant (Stone et al., 2008). Dans ces deux cas, l'énergie libérée dégage une chaleur intense qui accélère la dégradation du revêtement semi-conducteur. Lorsque ce revêtement est endommagé et que la surface de l'isolation de masse des barres sous tension fait face au noyau magnétique, l'activité de DP se produit entre ces deux surfaces et progresse latéralement en dégradant le revêtement semi-conducteur sur toute la surface de la barre. Dans ce cas, l'activité de DP d'encoche est de nature purement électrique. La Figure 1.3 illustre une barre d'alternateur qui a été soumise à des DP d'encoche de nature électrique. Le revêtement semi-conducteur appliqué sur la surface de cette barre a été érodé par l'activité de DP sur une grande section laissant paraître la surface de l'isolant.

Figure 1.3 Une barre ayant été soumise à des DP d'encoche de nature purement électrique

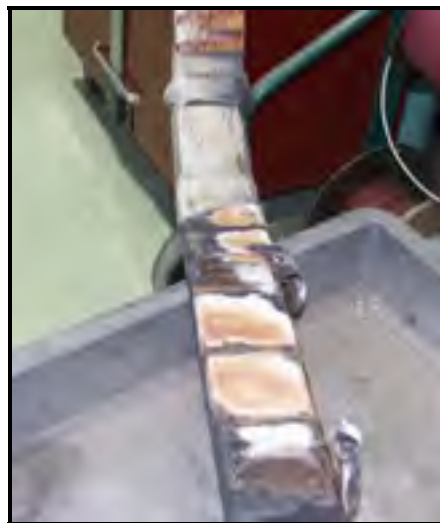
Figure 1.4 Une barre soumise à des DP d'encoche avec de la vibration mécanique

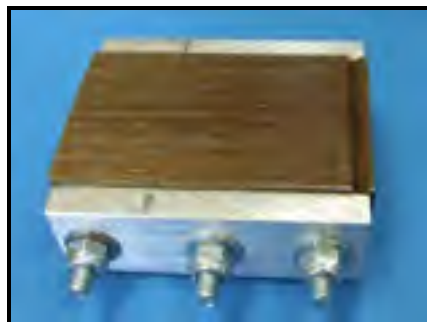
Figure 2.2 Lamination stack used for mechanical abrasion

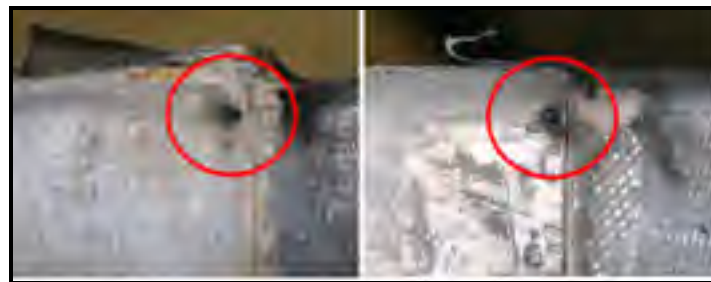
Figure 2.7 Failures sites of one slot PD site of bar 3B (left) and one site of bar 3A (right)

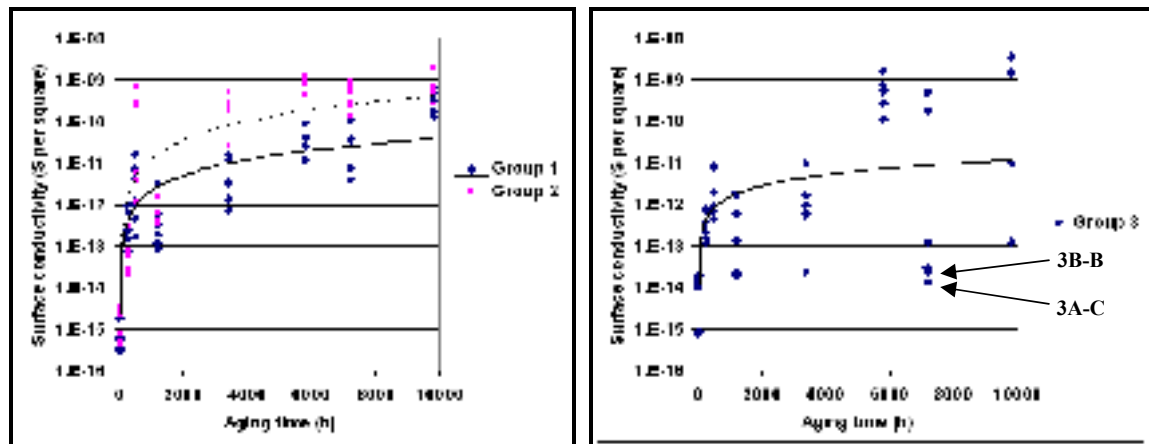
Figure 2.8 Surface conductivity measurements of epoxy-mica insulation surface for each slot PD site of group 1 and 2 (left) and group 3 (right)

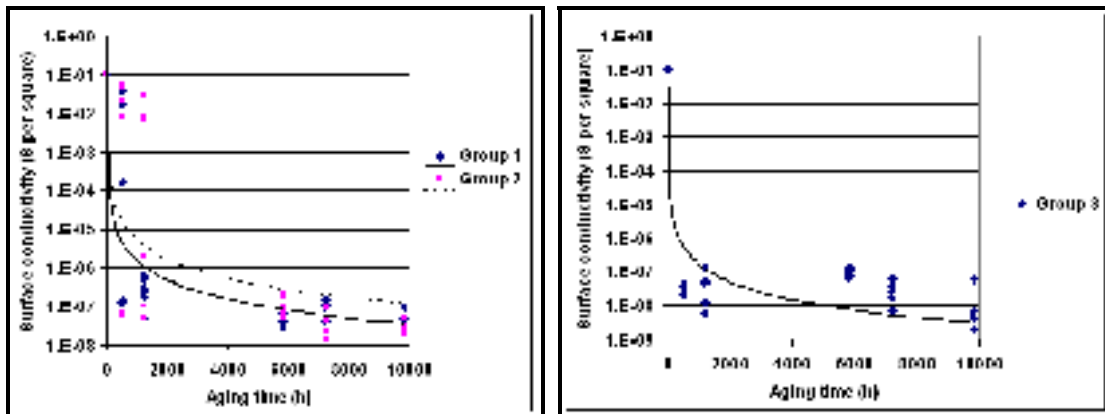
Figure 2.9 Surface conductivity measurements of the grounded electrode for each slot PD site of group 1 and 2 (left) and group 3 (right)

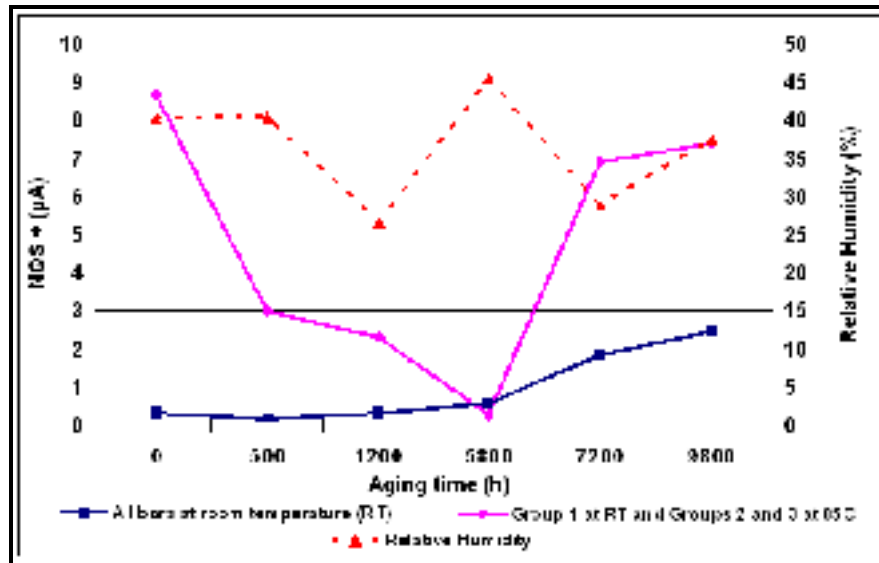
Figure 2.10 Evolution of the NQS + of all six bars in parallel measured with the capacitive coupler at room temperature and with bars of groups 2 and 3 at 85°C

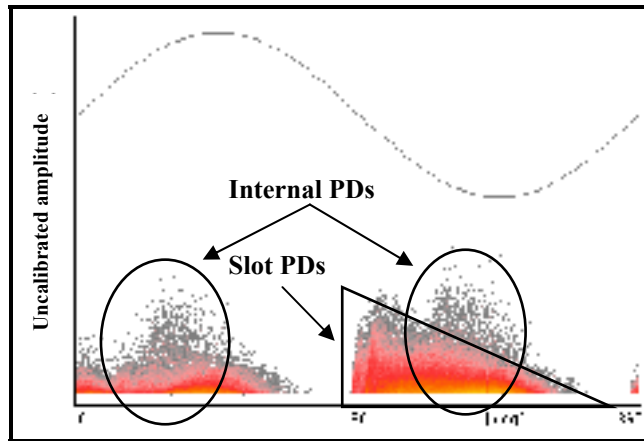
Figure 2.13 PRPD pattern measured at 8 kV in front of one slot PD site of bar 2A with the directional antenna at 85°C after 9800 h of aging time

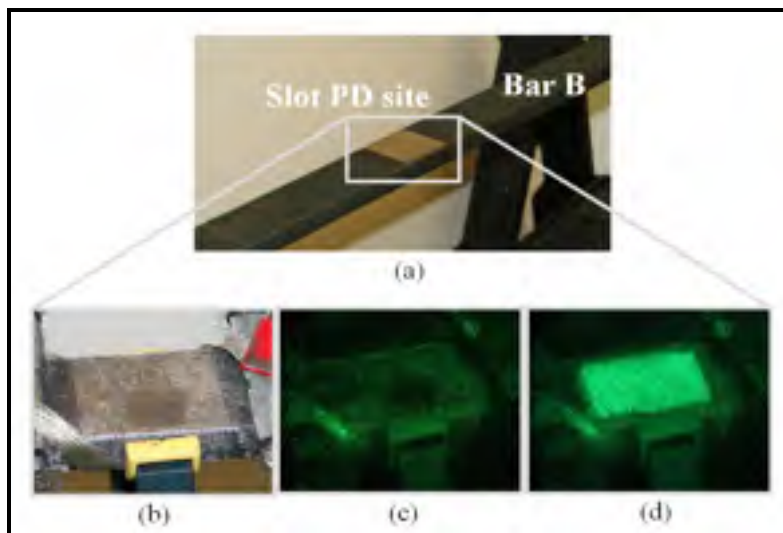
Figure 3.4 Arrangement for slot PD observation (a) a slot PD site without ground, (b) using a grounded steel wire mesh under room light, (c) with UV camera at 0 kV and (d) at 8 kV before surface degradation

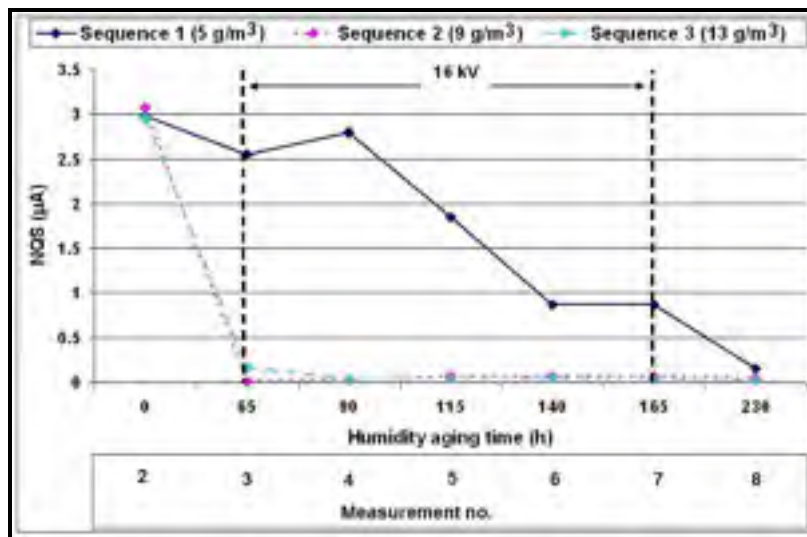
Figure 3.11 Evolution of the NQS of the slot PD site of bar A measured at 8 kV and 28°C for all aging sequences

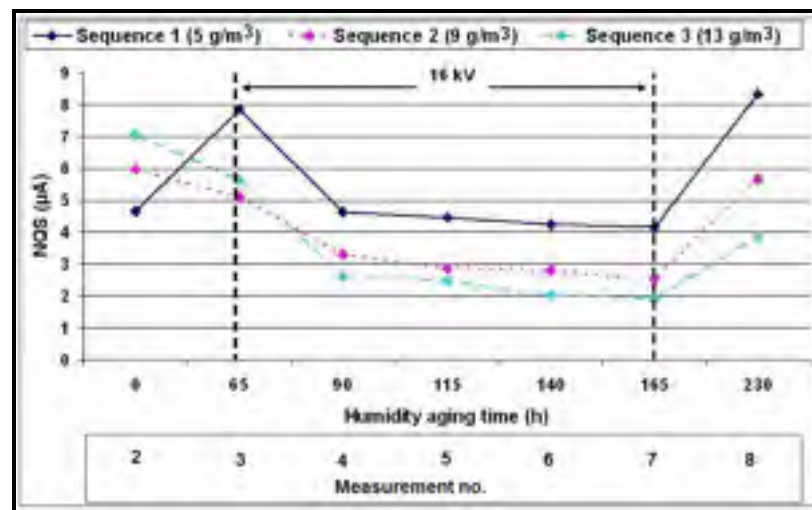
Figure 3.14 Evolution of the NQS of the slot PD site of bar B measured at 8 kV and 85°C for all aging sequences

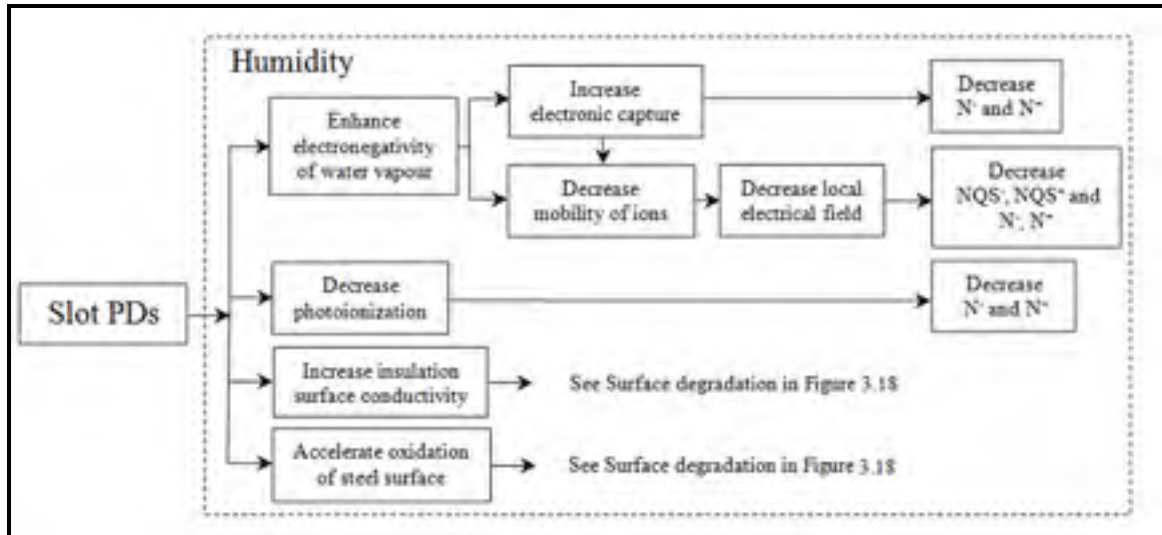
Figure 3.20 Summary of the cause and effect relationship of the influence of humidity on the slot PD activity

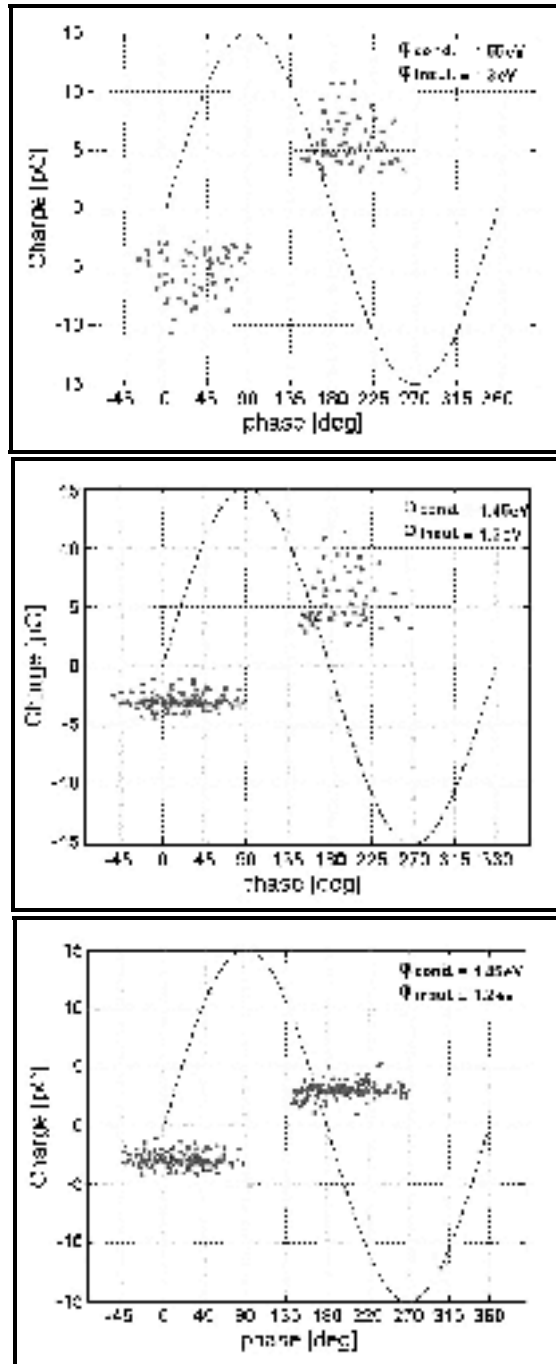
Figure 4.6 Distribution of PD events as a function of the applied voltage phase with $\phi_{\text{cond}} = 1.55 \text{ eV}$ and $\phi_{\text{insul}} = 1.3 \text{ eV}$ (top), $\phi_{\text{cond}} = 1.45 \text{ eV}$ and $\phi_{\text{insul}} = 1.3 \text{ eV}$ (middle) and $\phi_{\text{cond}} = 1.45 \text{ eV}$ and $\phi_{\text{insul}} = 1.2 \text{ eV}$ (bottom)

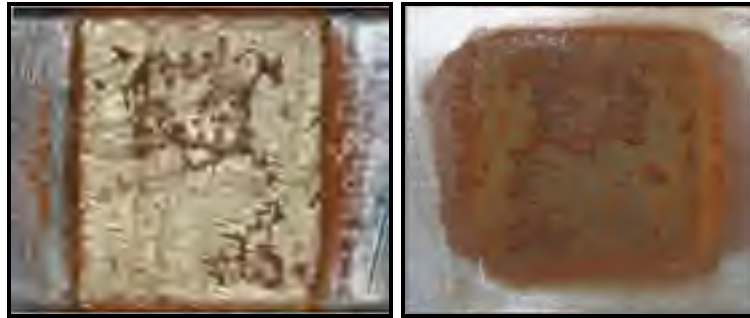
Figure 4.7 Surface deposits on the insulation surface and on the grounded electrode of one PD site

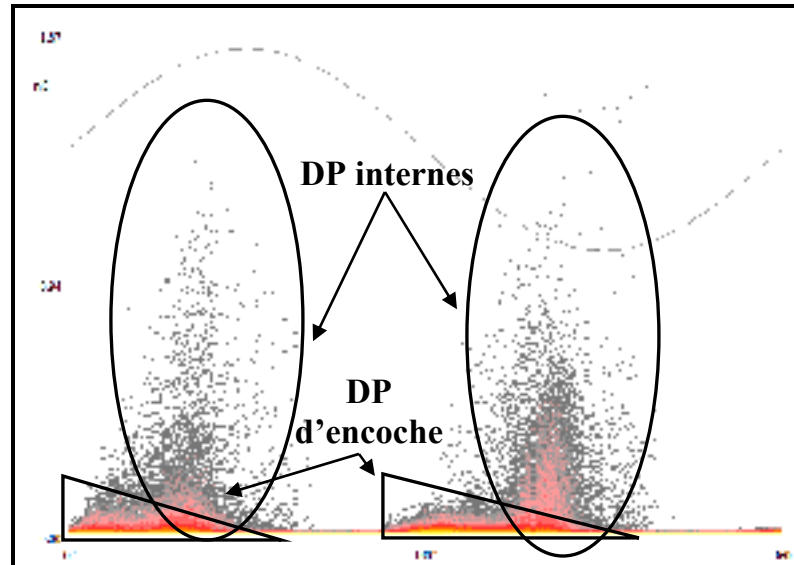
Figure 5.10 Signature PRPD mesurée sur la barre 3B à 7200 h avec un coupleur capacitif à 8 kV, à la température ambiante

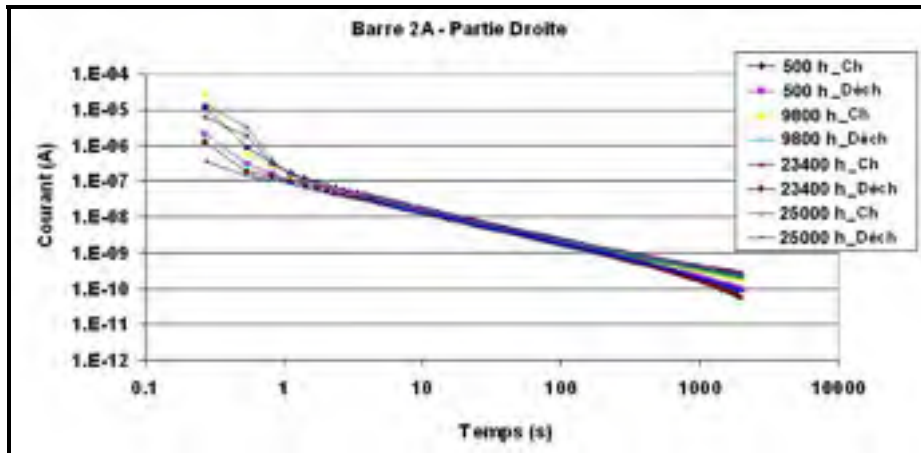
Figure 5.11 Les résultats des mesures de la réponse diélectrique de la partie droite de la barre 2A à une tension de 5 kV et un temps de charge et décharge de 2000 s

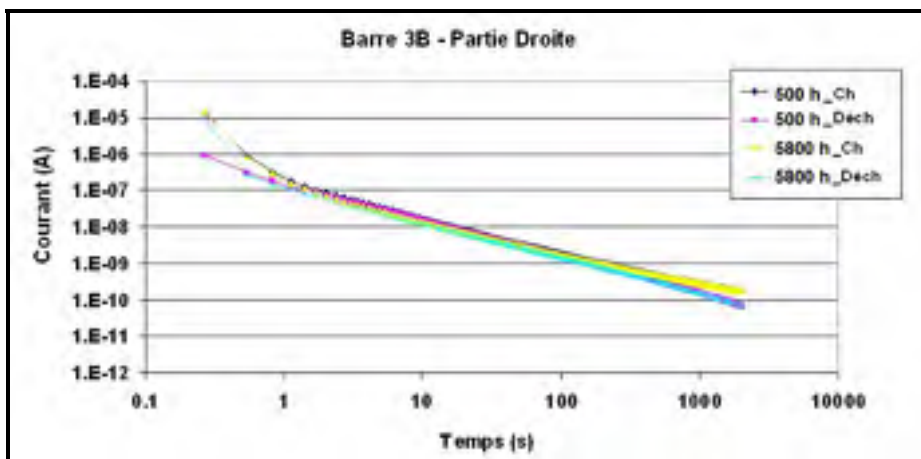
Figure 5.13 Les résultats des mesures de la réponse diélectrique de la partie droite de la barre 3B à une tension de 5 kV et un temps de charge et décharge de 2000 s

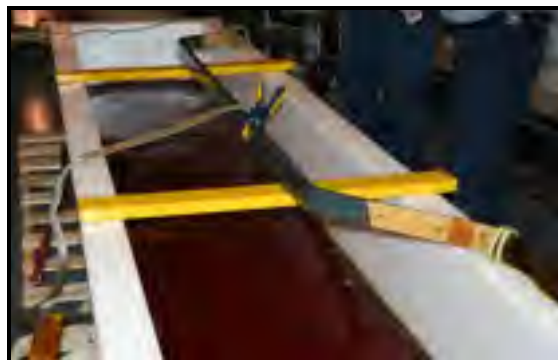
Figure 5.14 Le montage utilisé lors de l'essai de rupture diélectrique
