THESIS PRESENTED TO
ÉCOLE DE TECHNOLOGIE SUPÉRIEURE

BY
Abbasali SABOKTAKIN RIZI

INTEGRITY ASSESSMENT OF PREFORMS AND THICK TEXTILE REINFORCED
COMPOSITES FOR AEROSPACE APPLICATIONS

MONTREAL, DECEMBER 20, 2013

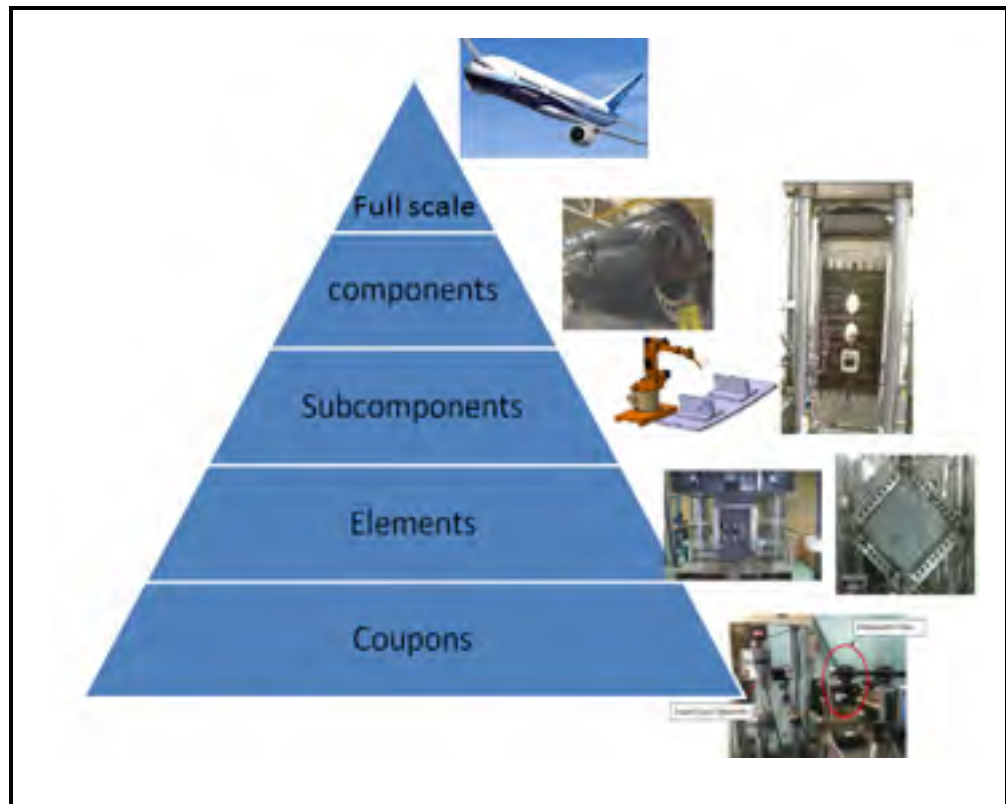
Figure 1. Test pyramid for aircraft composite structures.

- Figure 1 displays different levels of mechanical test known as the test pyramid for aerospace structures. Research results achieved at the coupon level in this thesis can be developed for larger structural elements, components, and complete assemblies in the aerospace industry.

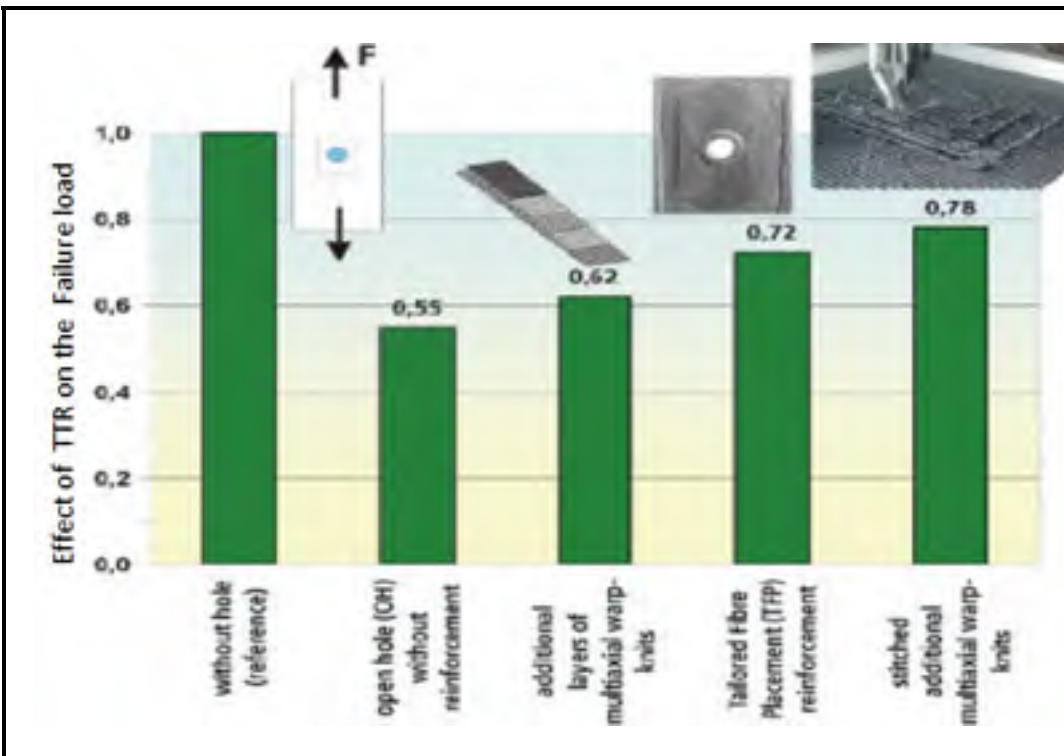
Figure 1.27. Comparison of strength of laminated and stitched composite (Sickinger C., Wilmes H. and Herbeck L., 2000)

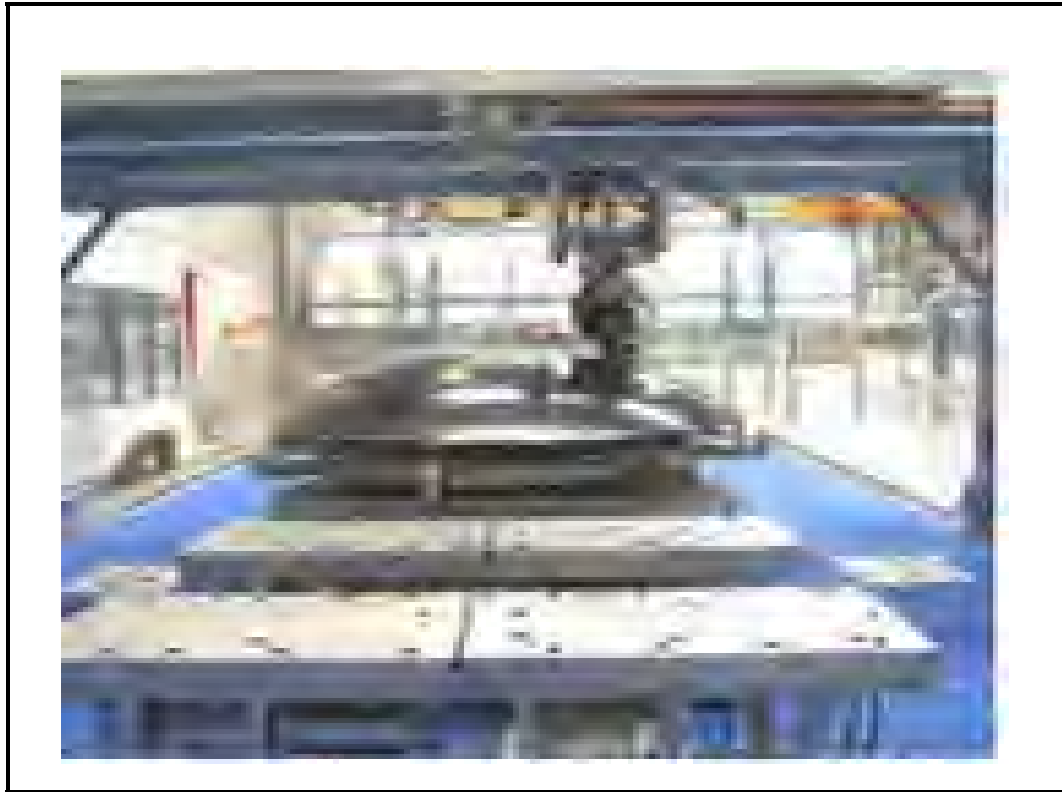
Figure 1.33. Example of ultrasonic C-scan of aircraft pressure bulkhead (<http://www.airbus.com>)

The fundamental principle of ultrasonic detection relies on pulses of high-frequency ultrasonic waves transmitted into the composite. These pulses are either transmitted through a specimen or reflected to the transducer by internal damage. The ultrasonic results are in the form of a C-scan, B-scan, or A-scan. By using ultrasonic C-scanning it is possible to detect delaminations and disbonds as well as volumetric defects including voids within the composite structure. Figure 1.33 displays an example application of pulse echo ultrasonic to inspect the pressure bulkhead of aircraft.

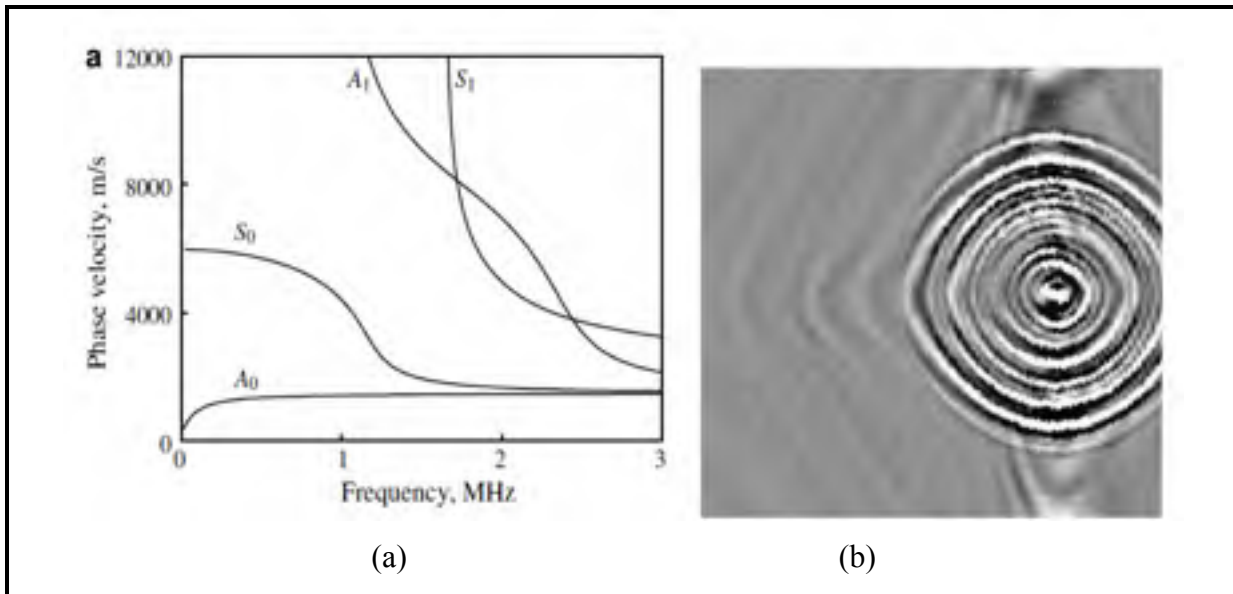
Figure 1.36. (a) Dispersion curve of Lamb wave modes (Yashiro S. and Takatsubo J., 2007)
(b) CFRP cross-ply and its visualized wave propagation

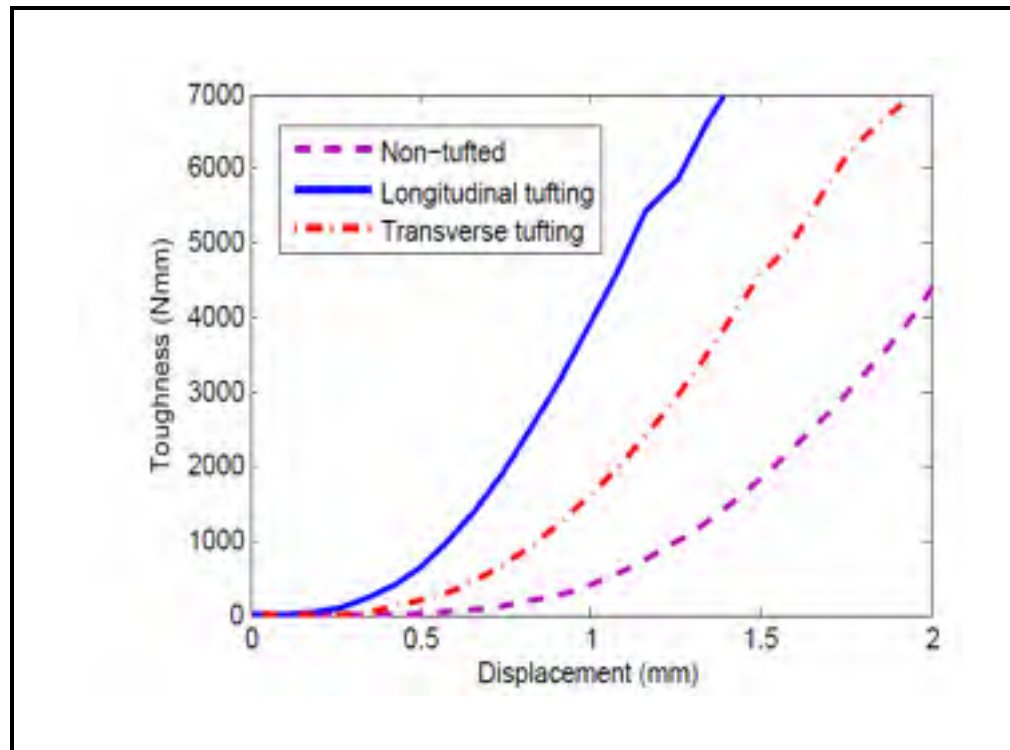
Figure 3.12. Typical toughness-displacement results from three specimens loaded in tension along the tufting direction, transverse direction and the warp direction.

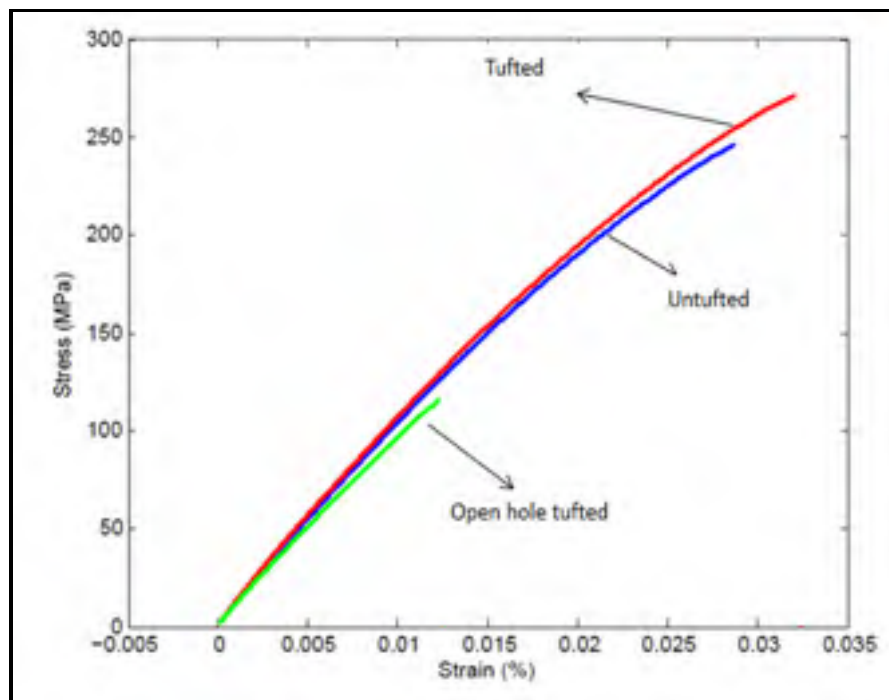
Figure 4.25. Post-fatigue tension test results
