Evaluation of the Reliability of Nondestructive Ultrasonic
Inspection Methods for the Detection and the Characterization
of Defects in Hydroelectric Turbine Welded Joints

MANUSCRIPT-BASED THESIS PRESENTED TO ÉCOLE DE
TECHNOLOGIE SUPÉRIEURE IN PARTIAL FULFILLMENT FOR THE
DEGREE OF DOCTOR OF PHILOSOPHY
Ph.D.

MONTREAL, MARCH 15TH, 2018

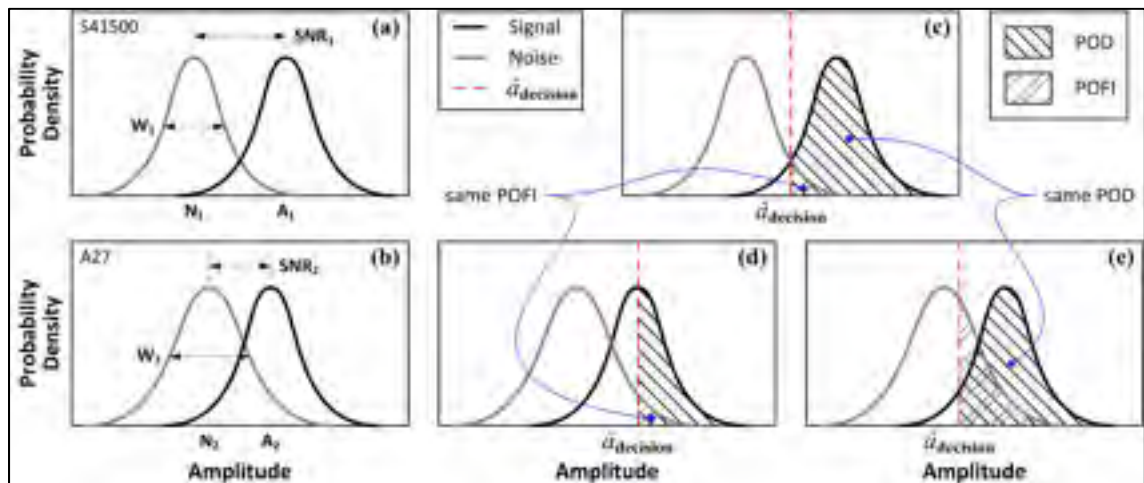
Figure 2.8 Effect of signal and noise distributions on POD and POFI; (a) represents low noise content and attenuation as compared to (b)

In summary, regardless of the $\hat{a}_{decision}$ threshold used, A27 will always yield either inspection reliability reduction, larger probability of defect free part rejection, or even both. In comparison, the S41500 grade yields superior inspection effectiveness.

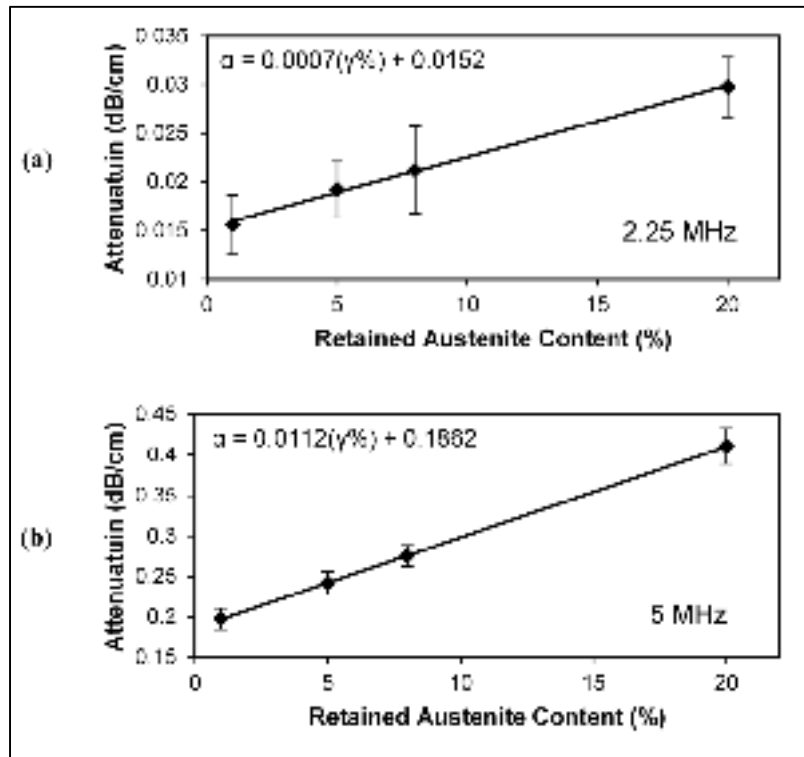
Figure 3.4 Longitudinal wave attenuation at (a) 2.25 MHz and (b) 5 MHz

attenuation rises with the γ -content at a greater rate due to shorter ultrasonic wavelength and accordingly more interaction with the extremely small γ -particles.

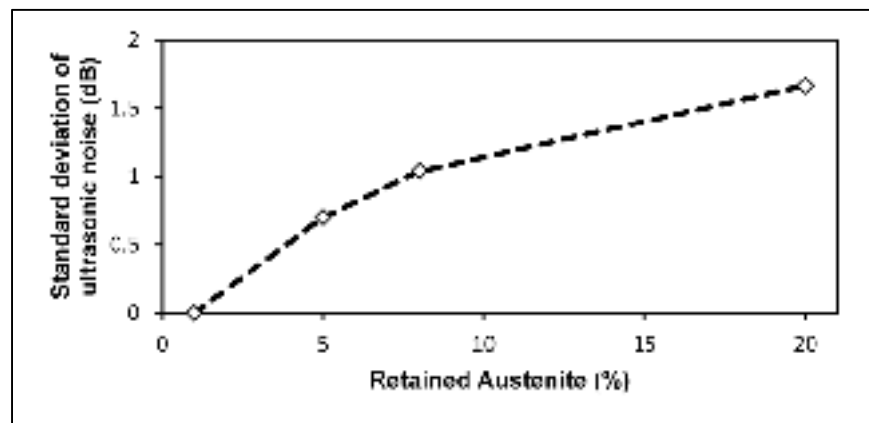
Figure 3.5 Standard deviation (SD) of the ultrasonic noise at 5 MHz

The backscattering noise level also increases with the reformed austenite content. The γ -particles reflect a portion of the wave in random directions and deviate the wave energy from its travelling path causing some part of this energy to return to the transducer as the backscattering noise. Considering the ultrasonic frequency and the size of scatterers, the experiments are in the Rayleigh region of scattering where there should be no effect of multiple scattering, as a contributor to the backscattering noise. In addition, the backscattering noise is the result of incoherent addition of the contribution of each scatterer; therefore, its amplitude does not increase significantly when the reformed austenite content increases. This is depicted in Figure 3.5 where the noise level for each sample is represented as the standard deviation (STD) of noise amplitude normalised with the one of sample 1.

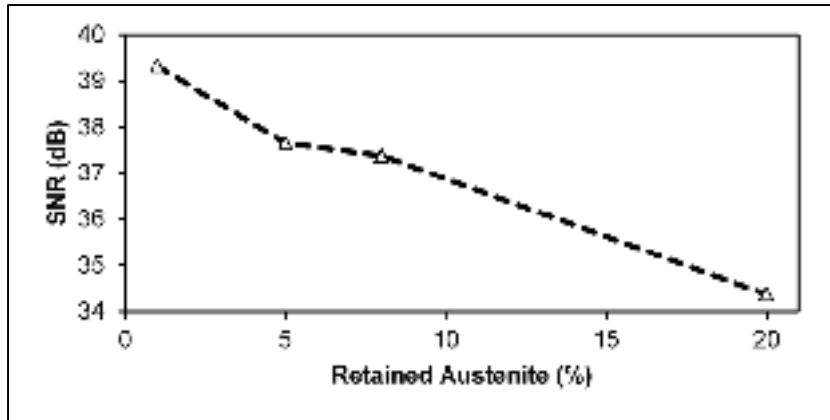
Figure 3.6 Signal-to-noise ratio (SNR) as a function of the reformed austenite content at 5 MHz

The result in Figure 3.6 shows the SNR average at the ultrasonic frequency of 5 MHz. SNR is a good metric to highlight the signal and noise amplitude change as a function of reformed austenite content. The backscattering noise level as well as the attenuation in the longitudinal wave inspection shows an increase with the reformed austenite content; however, the wave attenuation increases at a higher pace than the backscattering noise. This is to say that, in comparison with noise, attenuation is a greater contributor to the degradation of SNR with the growth of γ -content.

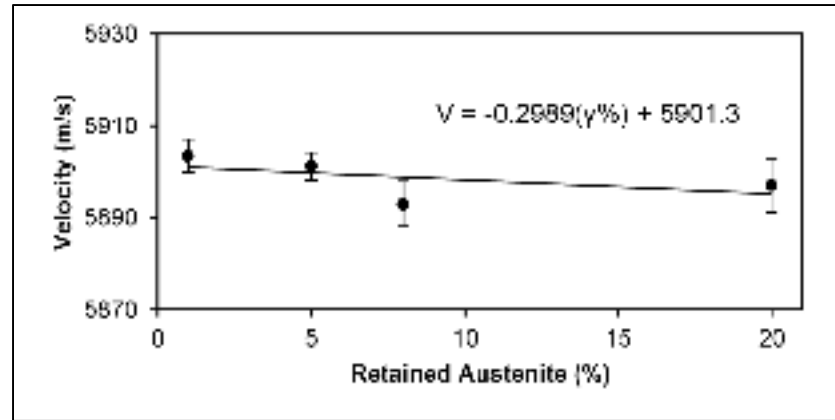
Figure 3.7 Longitudinal wave velocity at 5 MHz

As it can be seen in Figure 3.7, although a slightly decreasing correlation seems to appear between longitudinal wave velocity and reformed austenite amount, the significance of this correlation is dubious. According to Kruger *et al.* (Kruger & Damm, 2006), it was expected to observe a much larger reduction in the ultrasonic velocity with the formation of an increasing amount of reformed austenite (as much as 60 m/s over a 20% increase in retained austenite). This discrepancy could be attributed to the effect of tempering that relaxes residual stresses in the martensite matrix. In fact due to lower crystal distortion in the tempered martensite, ultrasonic waves will travel at higher velocities (Gür & Tuncer, 2004) so as to compensate velocity reduction caused by the presence of austenite phase.

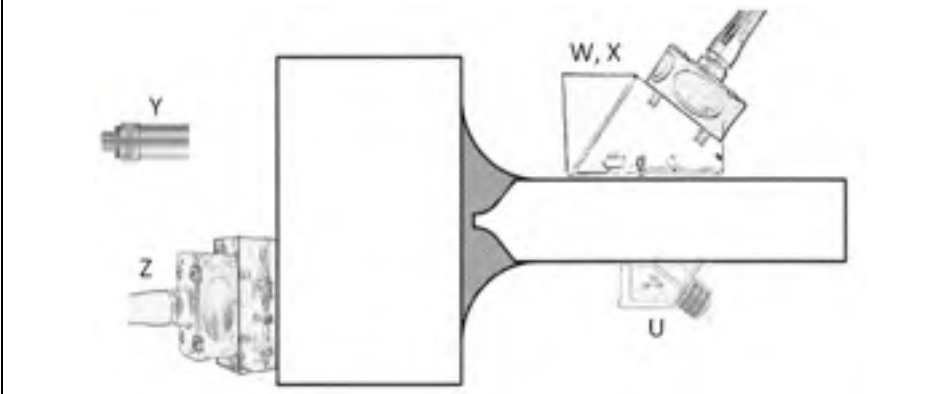
#	Inspection method	Scanned surface
T	Magnetic particles (MPI)	--
U	Conventional refracted ultrasonic shear waves	Web
V	Conventional and computed radiography	--
W	Manual phased-array ultrasonic (industrial standards)	Web
X	Manual phased-array ultrasonic (in-house method)	Web
Y	Immersion ultrasonic (in-house method)	Flange
Z	Manual phased-array ultrasonic (in-house method)	Flange

The diagram illustrates a T-joint structure. On the left, a vertical flange is shown with two inspection points labeled 'Y' and 'Z'. 'Y' is located on the top surface of the flange, and 'Z' is on the bottom surface. On the right, a horizontal web is shown with two inspection points labeled 'U' and 'W, X'. 'U' is located on the bottom surface of the web, and 'W, X' is on the top surface. The diagram shows the relative positions of these inspection points on the T-joint.

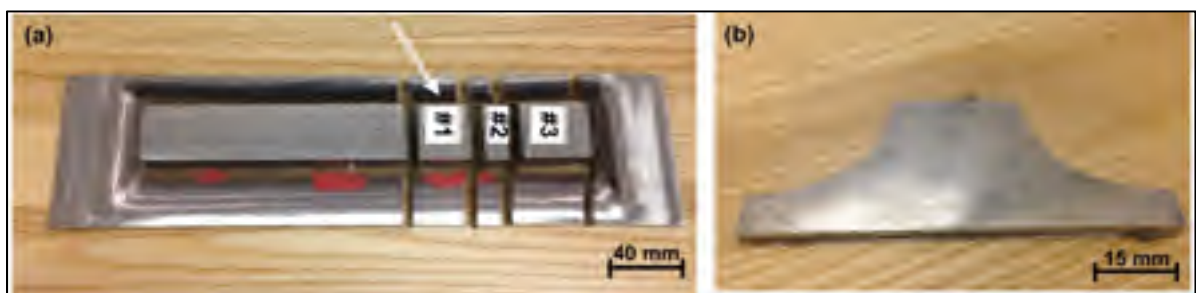
Figure 4.2 Principal cuts on the machined T-joint showing extracted samples used for destructive inspection and (b) one of the 1.5 mm thick slices cut-off from sample #1

determined using the results of the NDT methods. According to this intent, a 25 mm-long sample containing the targeted indication was extracted from the T-joint. The selected sample is shown as #1 in Figure 4.2(a). Afterwards, a precision slicing was used to make slices out of this sample with a nominal thickness of 1.5 mm, as depicted in Figure 4.2(b). Both faces of the precision slices were used to characterize the geometry and the type of flaw that produced the aforementioned indication.

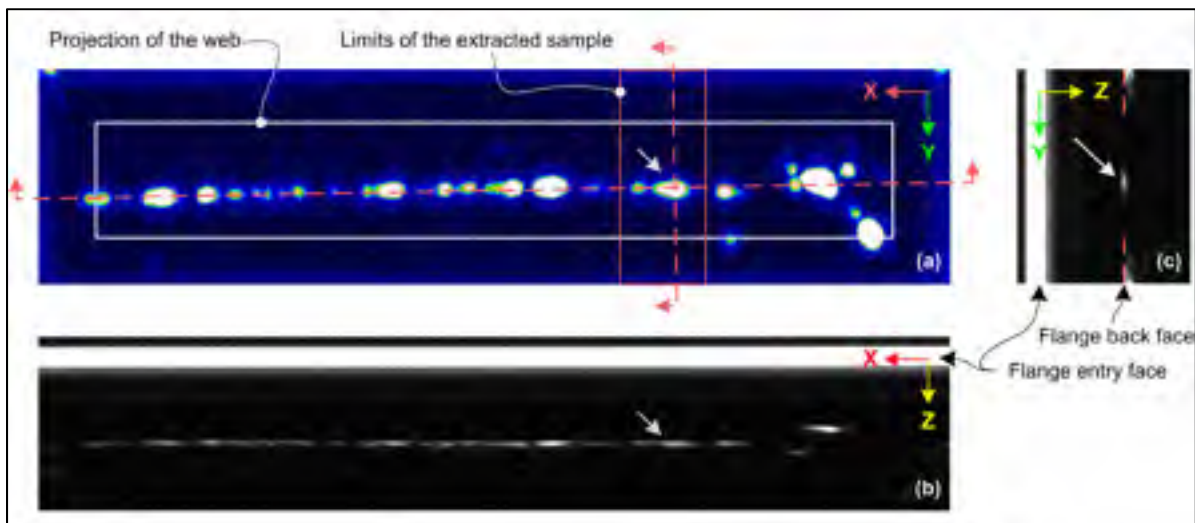
Figure 4.3 Results of method Y (a) C-scan representation; (b) and (c) B-scan representation on a plane passing through the selected indication parallel and normal to the x-axis, respectively

ultrasonic inspection (method Y) which is carried out using a 5 MHz flat transducer ($\varnothing 10$ mm) scanning the weld from the flange face is shown in Figure 4.3. The C-scan representation in Figure 4.3(a) provides a view from the bottom face of the flange; the vertical box indicates sample #1 which was extracted from the T-joint. According to these results, a series of discontinuities more or less aligned with the joint centreline at a depth approximately equal to the flange thickness is observed. Due to its features (including size, position and orientation), the indication pointed out by the arrow is not detected by the standard NDT methods (T to W). However, the better accessibility to the welded joint from the flange face enables method Y to reveal the presence of a clear discontinuity in the aforementioned location.

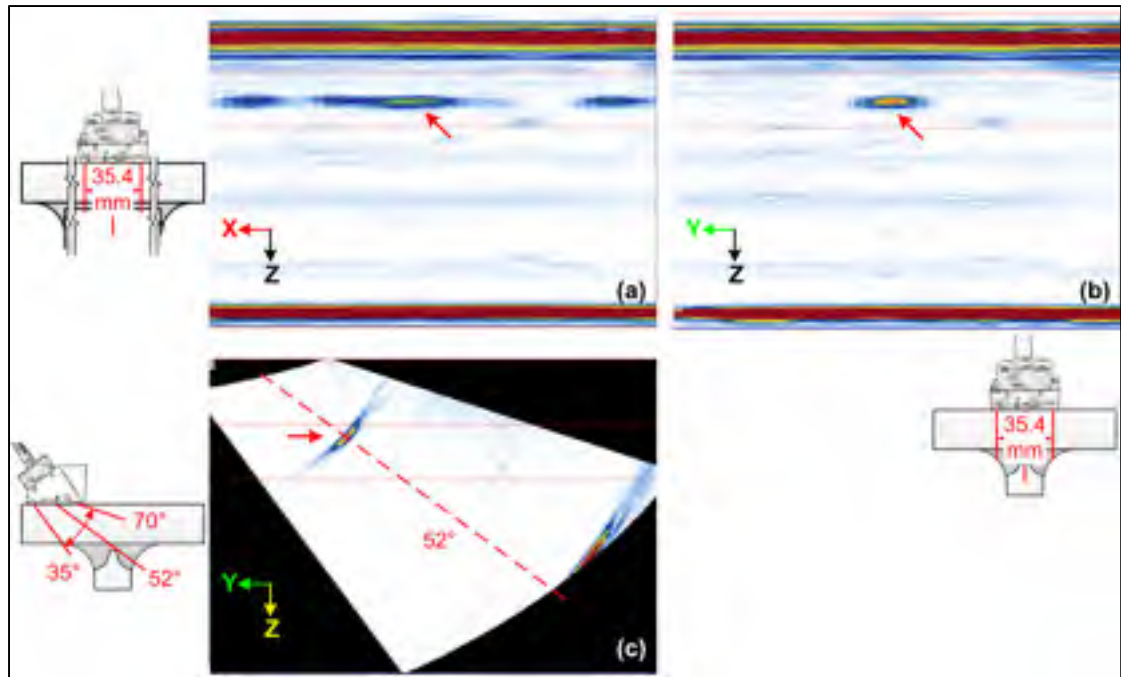
Figure 4.4 (a) and (b) E-scan and (c) S-scan results obtained with method Z in the vicinity of the selected flaw. The arrows point out the flaw indications

perpendicular direction (Figure 4.4(b)), the position of the indication center relative to the T-joint centreline is found to be in accordance with the immersion results from Figure 4.3(c). In addition, as shown in the refracted shear waves sectorial scan (S-scan) of Figure 4.4(c), the flaw indication is maximized at an angle of 52° relative to the normal of flange face.

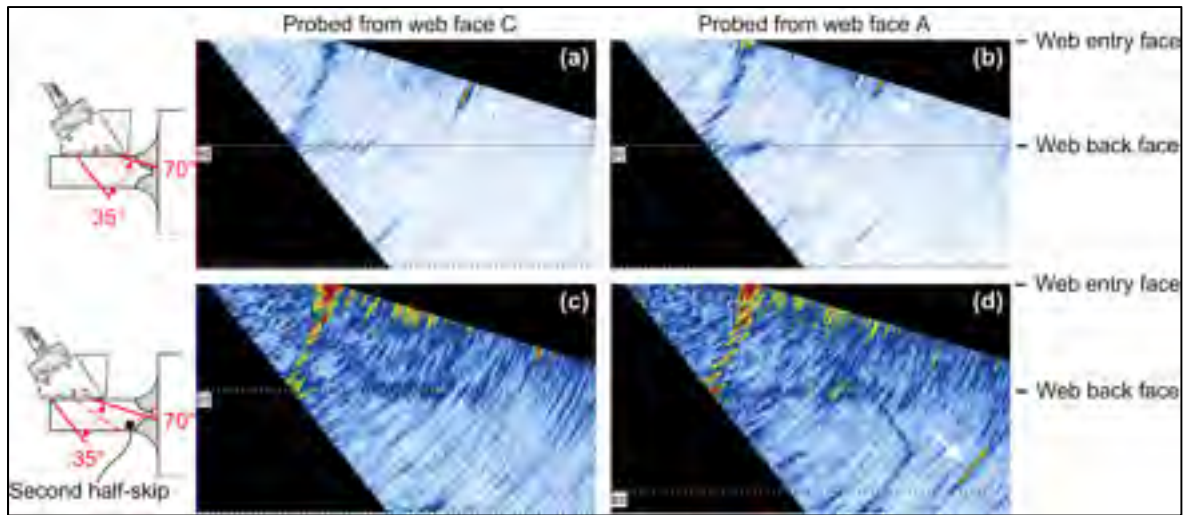
Figure 4.5 PAUT results at two different distances from the weld axis on web faces. The arrows point out the flaw's indication

Method X is a phased-array ultrasonic testing (PAUT) inspection within which a 64 elements transducer of 5 MHz scans the weld over the web faces. With this method, refracted shear waves are swept from 35° to 70° as shown in Figure 4.5. On face C (Figure 4.5(a)), an indication was observed on the first half-skip at a refracted angle ranging from 65° to 69° with respect to normal. However, on face A (Figure 4.5(b)), a much smaller signal is received on the first half-skip at a refracted angle of 70° . On the second half-skip, while on face A (Figure 4.5(d)), a clear indication is found at a 55° refracted angle. On the contrary, from face C (Figure 4.5(c)), the flaw's signal is not resolvable from the noise.

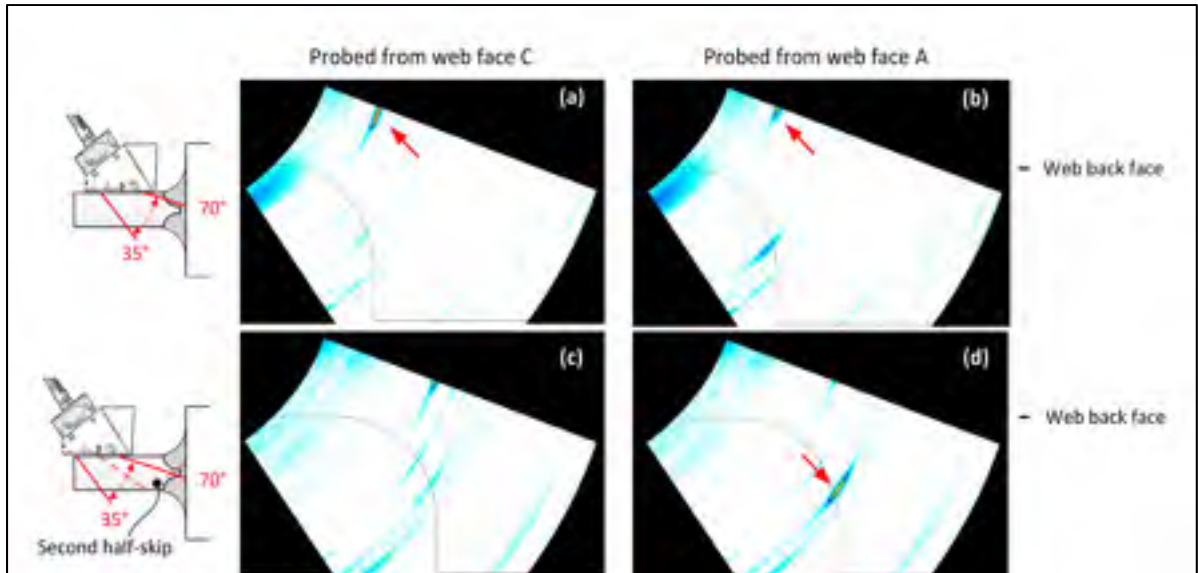
Figure 4.6 Simulation of PAUT results at two different distances from the weld axis on web faces; the gain for images (c) and (d) is higher than for images (a) and (b)

Based on the outcome of NDT inspections around the selected indication, it is suspected to be due to an inclined lack of penetration (LOP) at the flange/weld interface on the centreline of the T-joint where lack of appropriate accessibility during welding could promote the formation of LOP. In order to validate such a hypothesis, a planar flaw representing the LOP is inserted at the flange/weld interface of a CIVA simulation model (Dib *et al.*, 2016). The semi-analytical results, provided in Figure 4.6, yield similar signals to the experimental PAUT results shown in Figure 4.3. Since the LOP is not perpendicularly oriented relatively to the incident waves direction, it won't reflect the shear waves back to the transducer; however, signals diffracted by the extremity of the planar flaw (tip diffracted signals) could be received by the transducer because they are spherical waves.
