DIELECTRIC FREQUENCY RESPONSE ANALYSIS
APPLIED TO STATOR WINDING INSULATION
SYSTEMS

THESIS PRESENTED TO ÉCOLE DE TECHNOLOGIE SUPÉRIEURE
IN PARTIAL FULFILLMENT FOR A MASTER'S DEGREE
WITH THESIS IN ELECTRICAL ENGINEERING
M.A.Sc.

This study presents the results of investigations that were performed to verify if the use of low-voltage dielectric frequency response analysis can be successfully applied to detect the deterioration of stator winding insulation systems.

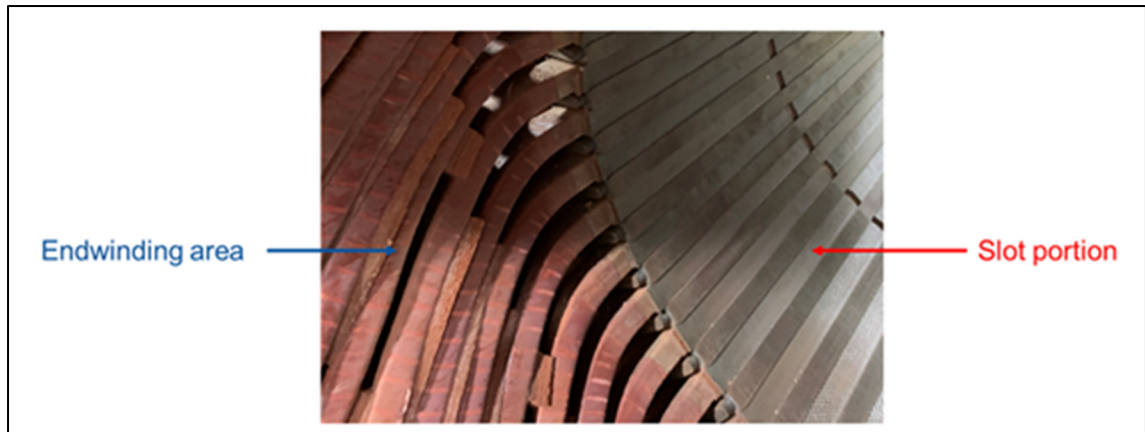
Figure 1.9 Picture of a stator winding making the distinction between the slot portion and the endwinding area

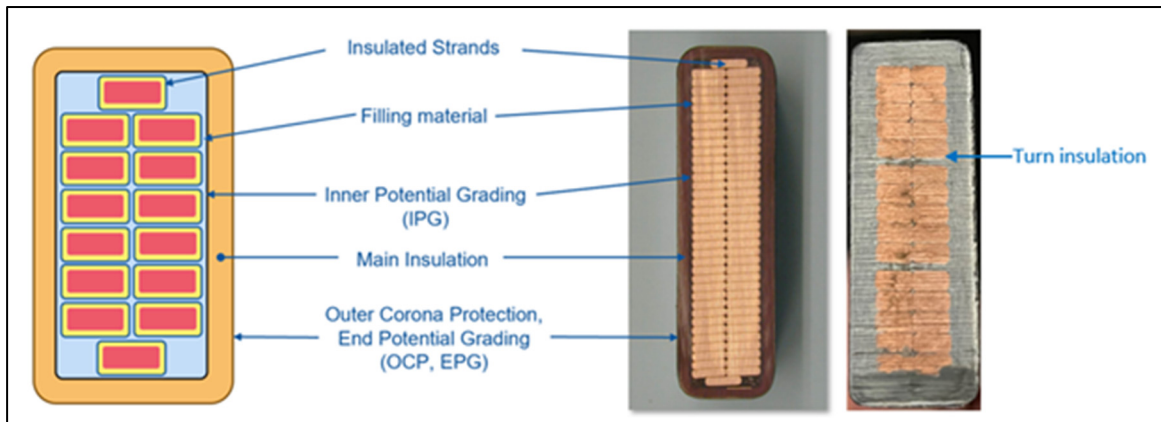
Figure 1.10 Cross-sectional cuts of a stator bar and a stator coil
Adapted from OMICRON (2023, p. 34)

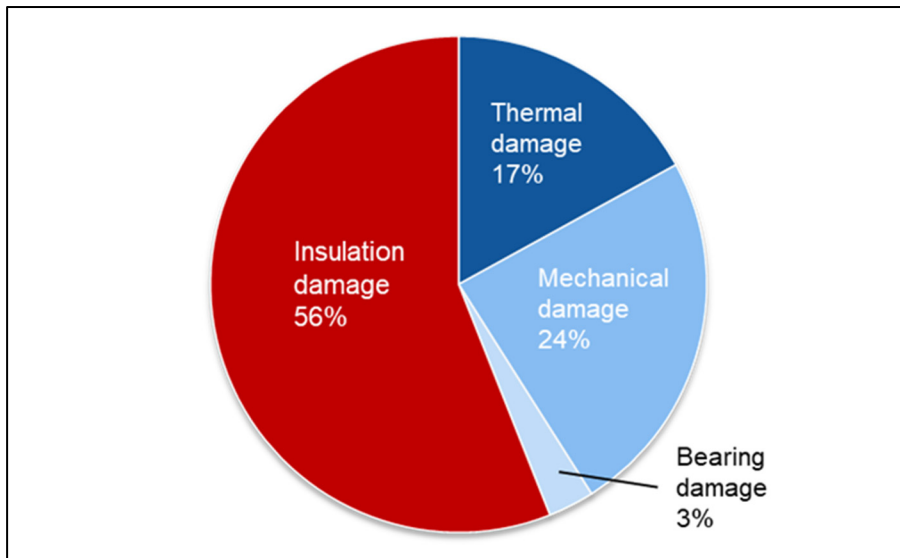
Figure 2.1 Attributed causes of failure from 69 hydro generators
Taken from OMICRON (2023, p. 4)

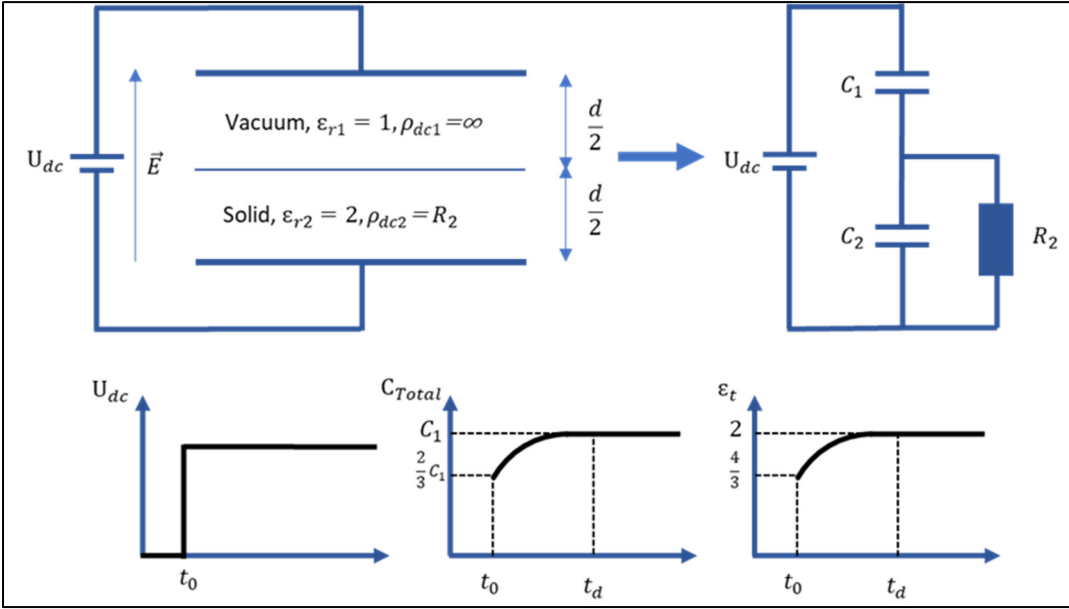
Figure 3.4 Polarization under direct voltage
Adapted from Ravindra & Wolfgang (2022, p. 353)

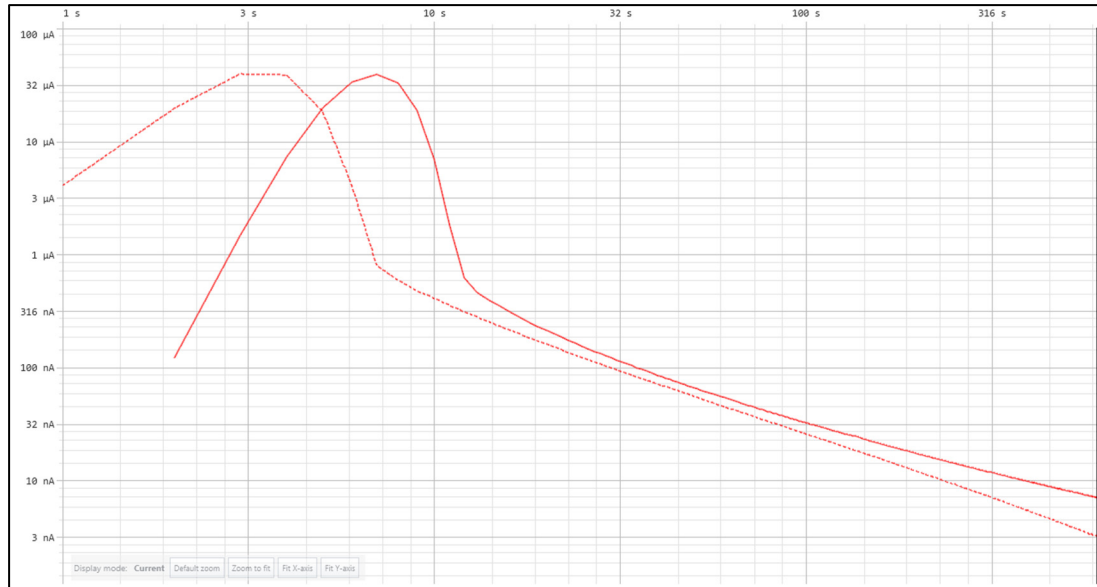
Figure 3.5 Example of a measured polarization (solid) and depolarization (dash) current on a hydro generator

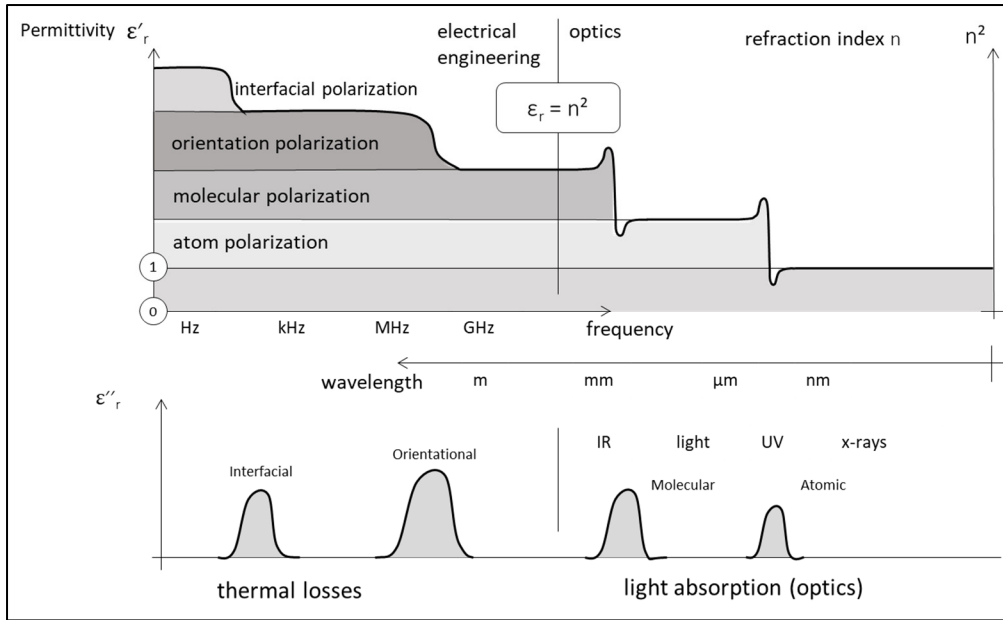
Figure 3.7 Sketch showing the frequency dependence of different polarization mechanism

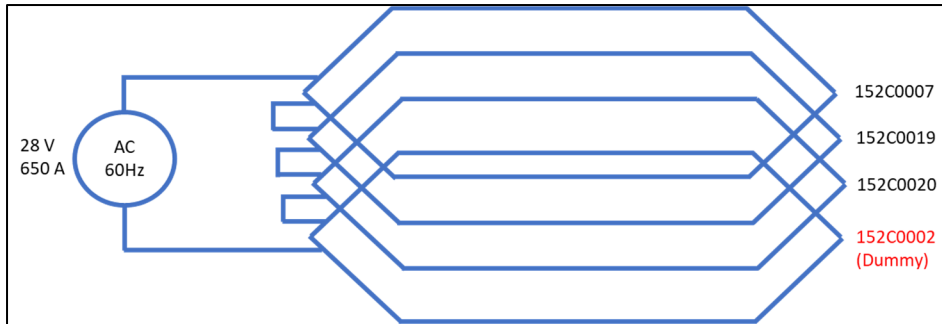
Figure 4.3 Connection diagram of the coils for the thermal cycling test

The thermal cycling is achieved by connecting some coil specimens together and by circulating an AC current through the formed closed circuit. Usually, four coils are used for the test, including one dummy coil. The definition of dummy coil is described later in this paragraph. The current must be sufficient to raise the temperature of the copper to the thermal class temperature of the insulation system under test. In the case of this experiment, the coils were of thermal class F and therefore, the temperature was raised to 155 degrees Celsius in approximately 42 minutes. When the upper temperature was reached, the current was decreased back to zero and fans were used to cool down the coils to a temperature of 40 degrees Celsius in approximately 42 minutes. This sequence is considered one cycle and is repeated 500 times (total ageing is 500 cycles). During this test, no high voltage is applied beside the small voltage drop that is built across the complete circuit formed by the coils. The temperature is monitored using what is called a dummy coil. Holes are drilled at different locations in the dummy coil and thermocouples are inserted to monitor the temperature. A connection schematic is available in figure 4.3 while a picture of the thermocycling test bench is available in figure 4.4.

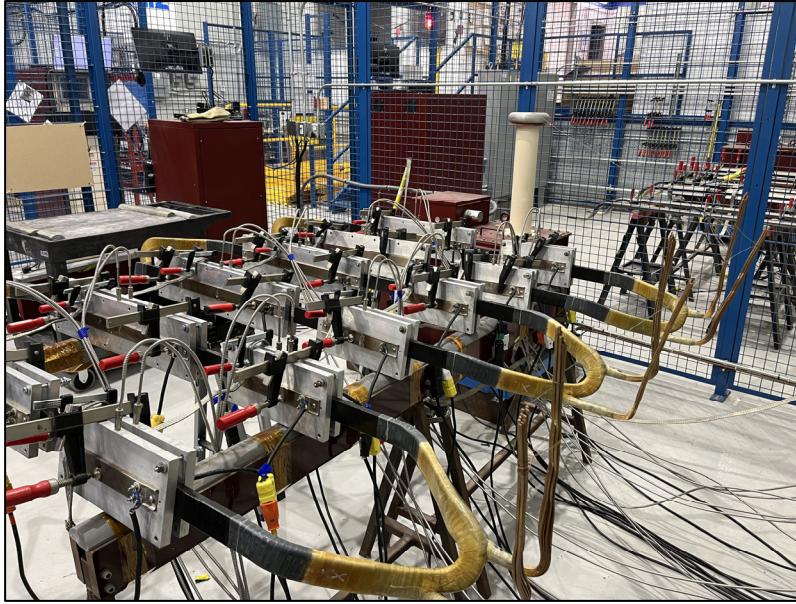
Figure 4.6 Picture of the test bench for the voltage endurance test

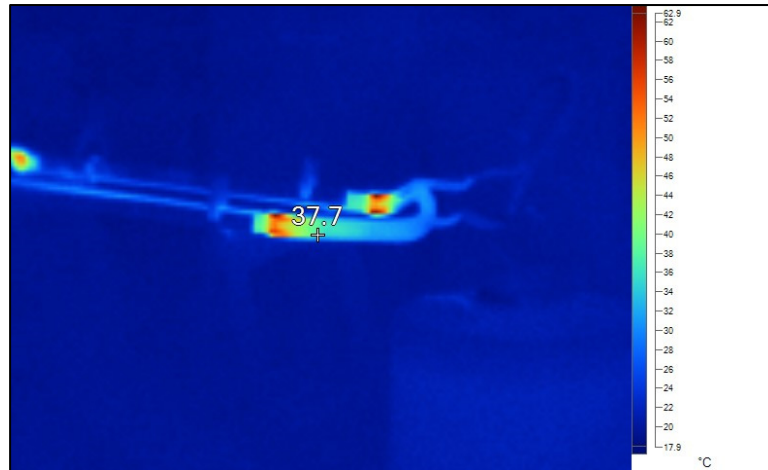
Figure 4.7 Picture of the coil three hours after the beginning of the stage 3 ageing process

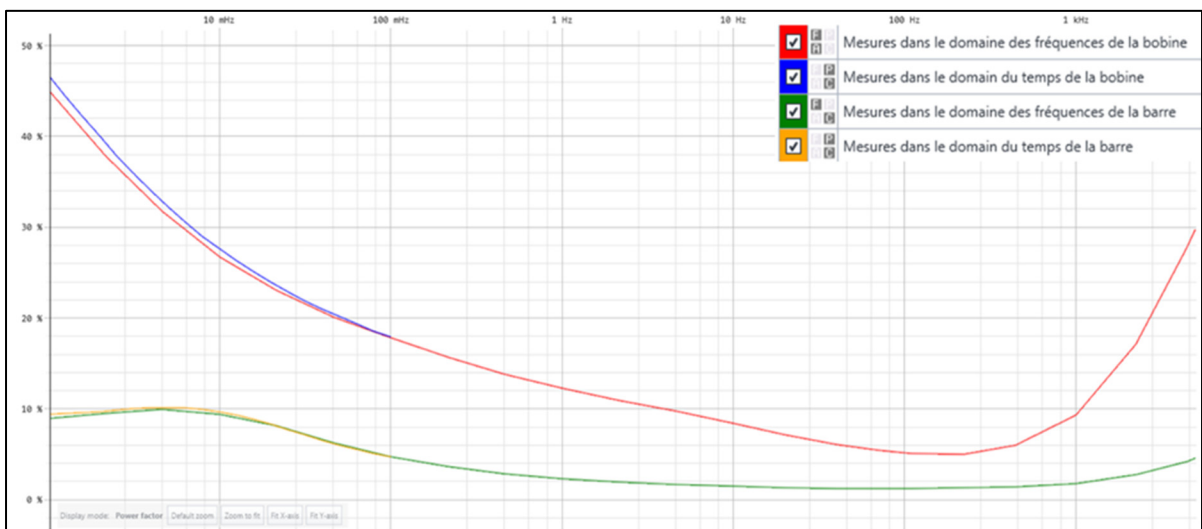
Figure 5.1 Comparison of the obtained DFR curves for the measurements using PDC and FDS, for two different test objects

It was explained in chapter 3 that it is possible to convert the data obtained from time domain measurements in the frequency domain using Fourier transform. The DIRANA also converts the data from the time domain measurements into the frequency domain. To this end, the equipment uses the polarization current to convert the data in the frequency domain. However, the algorithm that is used is proprietary and can't be disclosed in this document. To verify the accuracy of the algorithm, measurements were performed on the same test objects in the time domain (PDC) and in the frequency domain (FDS). The results for one coil and one bar are shown in figure 5.1, where the x-axis shows the applied frequencies, and the y-axis shows the measured DF. These test objects were not the same as the ones used for the experiments described in this document. However, their insulation system was similar. The results are very similar.

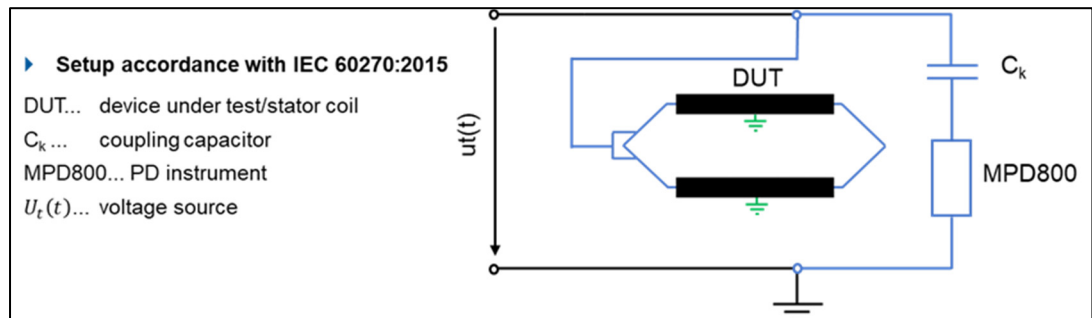
Figure 5.3 Schematic of the test setup used for PD measurements

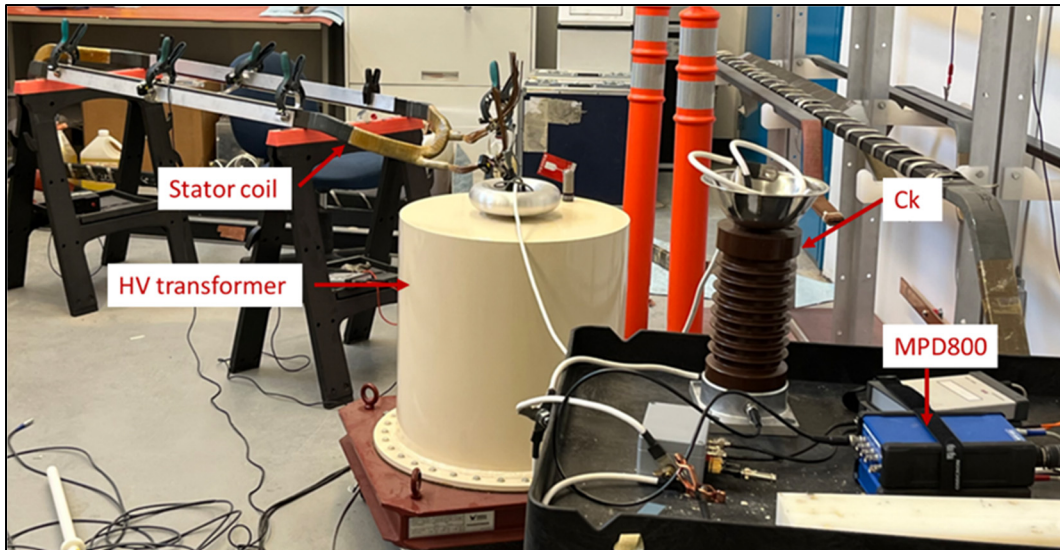
Figure 5.4 Picture of the test setup during PD measurements

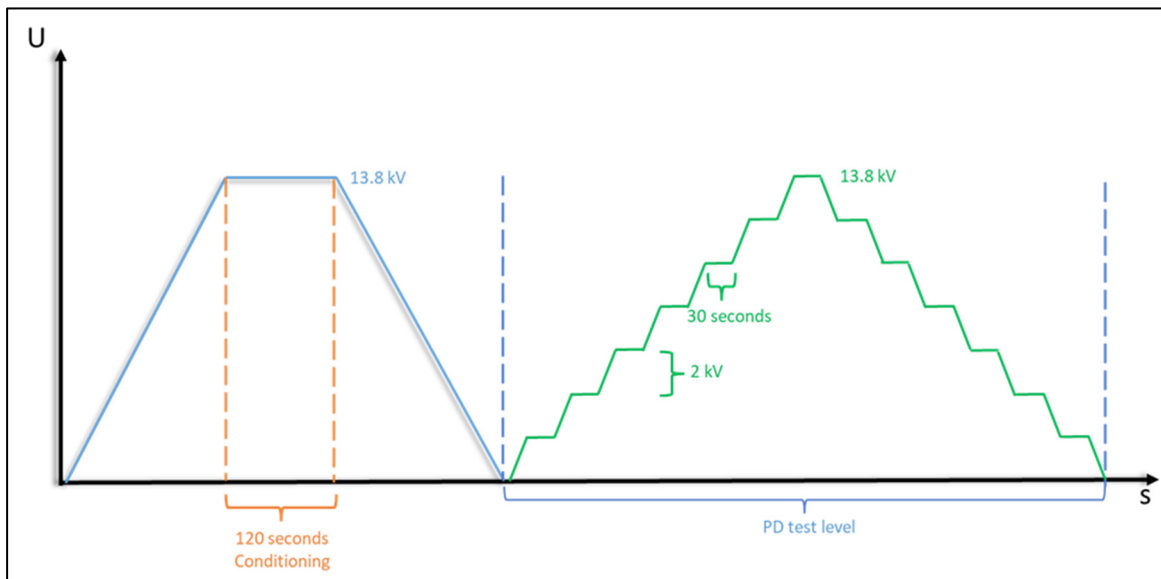
Figure 5.5 Applied voltage test sequence used for the PD measurements

Prior the measurements, each phase was conditioned by applying a sinusoidal voltage of 13.8 kV_{RMS} for a period of 120 seconds. The conditioning period is described in (IEEE, 2014); (IEC, 2006) and is used to obtain stable, repeatable, and comparable PD measurement results. PD magnitudes, which is expressed in picocoulombs (pC) or nanocoulombs (nC), usually tend to decrease upon energization. Following the conditioning period, the measurements were performed by applying a voltage from 0 V up to 13.8 kV_{RMS} in steps of 2 kV_{RMS} and with a duration of 30 seconds at a frequency of 60 Hz. The digital filters of the PD instrument were set with a center frequency of 250 kHz and a bandwidth of 300 kHz for all measurements. The charge values are weighted according to table 1 of IEC60270 (Q_{IEC}). This weighting process is automatically done by the MPD800. The reported values in this document are the average of the Q_{IEC} values over a period of 20 seconds. This averaging is automatically done by the MPD800. Figure 5.3 shows a schematic of the test setup, figure 5.4 shows a picture of the test setup and figure 5.5 shows the applied voltage profile for the PD measurements.

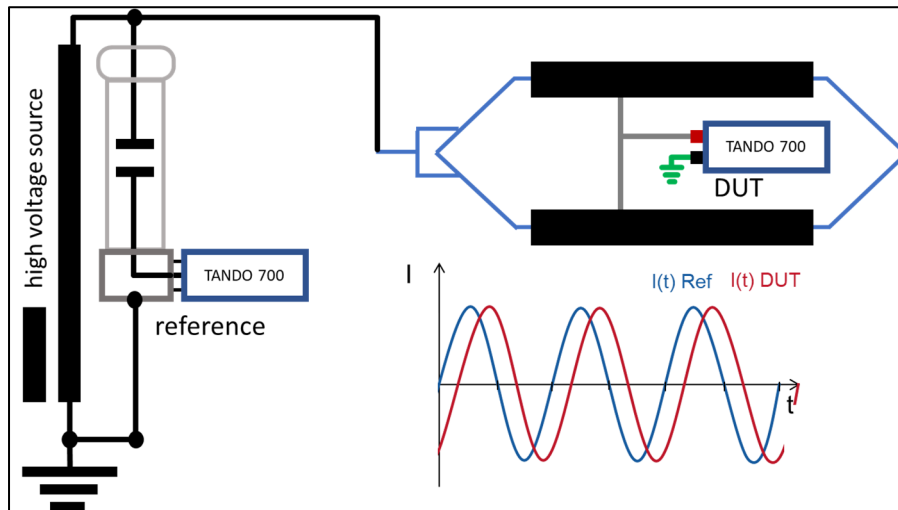
Figure 5.8 Schematic of the test setup used for the conventional DF measurements

An introduction to dissipation factor (DF) measurements was done in section 2.2.5. The dissipation factor was measured using the TANDO700 (OMICRON, 2017) fromOMICRON. The measuring principle is similar to the DFR measurements described earlier but, for one single frequency (60 Hz). The TANDO700 has two measuring units (impedances). One of those units is connected in series with a low-loss reference capacitor while the second unit is connected in series with the ground path of the test object. The two measured currents are then compared to extract the losses of the test object. The current flowing in the reference capacitor is assumed to with low loss and with a phase angle of 90 degrees in reference to the applied voltage. The reference capacitor used for the measurements at a value of 1 nF and measurements were performed at 0.4 kV_{RMS}, 2 kV_{RMS}, 4 kV_{RMS}, 6 kV_{RMS} and 8 kV_{RMS}.

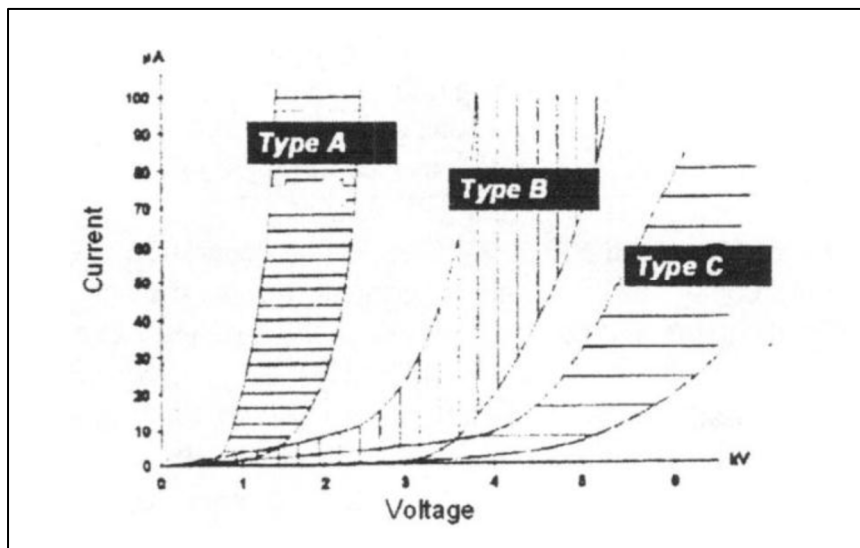
Figure 6.1 Typical V-I curves of EPG
Taken from Conley & Frost (2005, p. 92)

EPG coatings are made using grains of silicon carbide (SiC). Small particles of SiC are held in a resin-type based material which can be cured the same way as the main insulation material. This compound has usually just enough conductivity to carry the capacitive current from the main conductor through the insulation without a significant increase in the electric field along its surface (Taylor, 2006). The design of the EPG results in a non-linear V-I curve where, the current increases exponentially as the voltage is increased beyond a certain threshold. Therefore, when there is an increase of the electric field along the surface of the EPG, the resistance will decrease which will prevent the electric field to increase beyond a certain critical value. This value is related to the breakdown voltage of the air. The exact V-I curves depend on many factors such as the level of metallurgical purity and the dosage used in the mixture during manufacturing. The exact mixture used for stator windings is proprietary to most machine manufacturers and varies depending on the design needs (Conley & Frost, 2005). Figure 6.1 shows the V-I curves of three different mixtures of EPG used for stator windings.

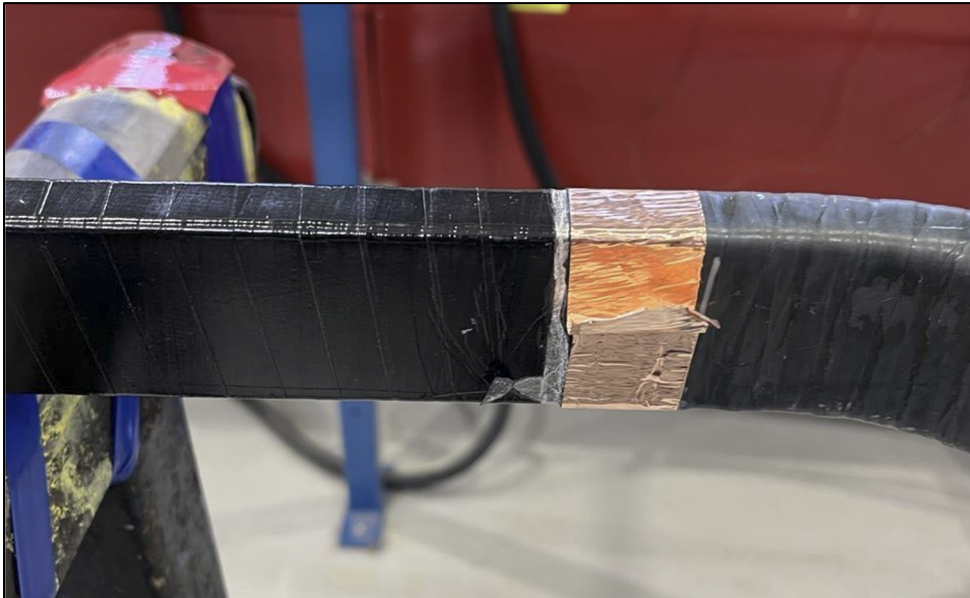
Figure 6.2 Picture of one of the guard electrodes installed on coil 02

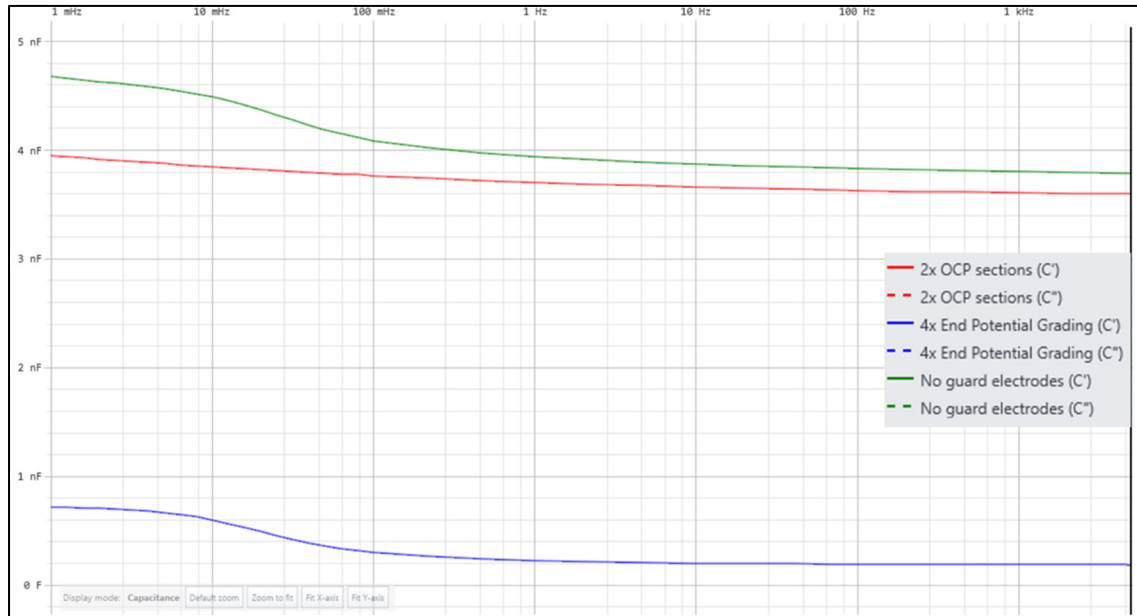
Figure 6.3 Guarded and unguarded measured real capacitance of the slot sections and the EPG sections using linear Y-scaling

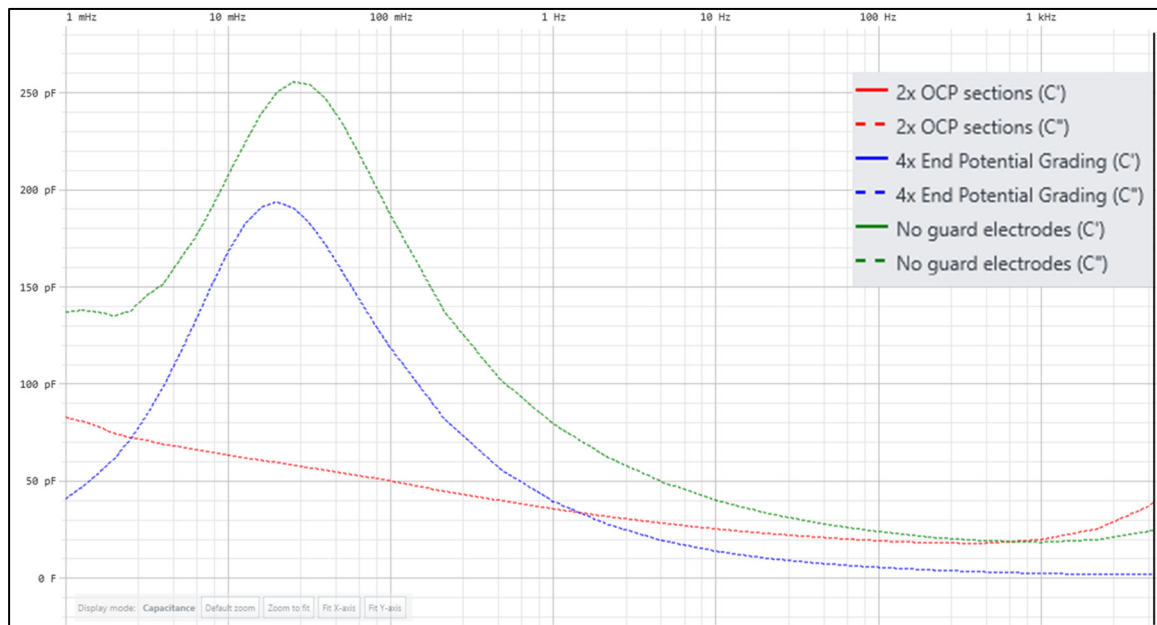
Figure 6.4 Guarded measured imaginary capacitance of the slot sections and the EPG sections using linear Y-scaling

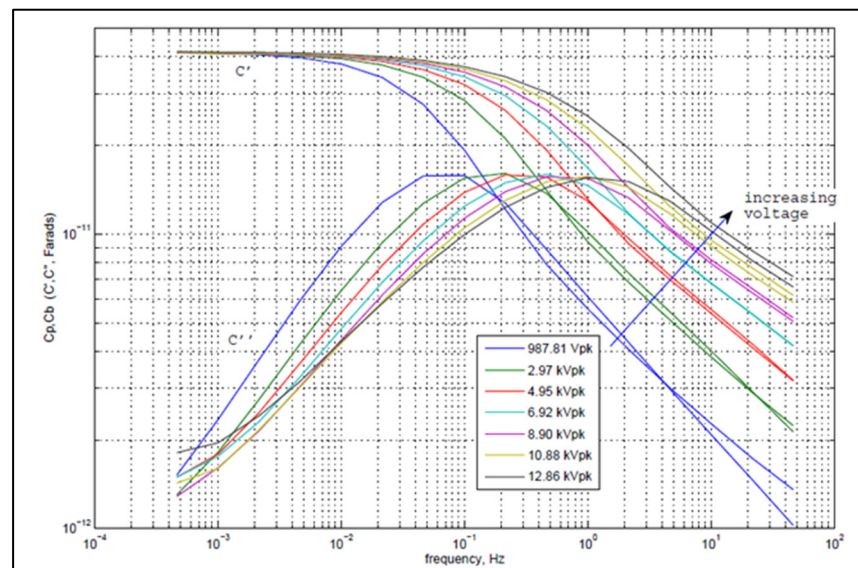
Figure 6.5 Complex capacitance measured from the PTFE tube
Taken from Taylor (2010, p. 186)

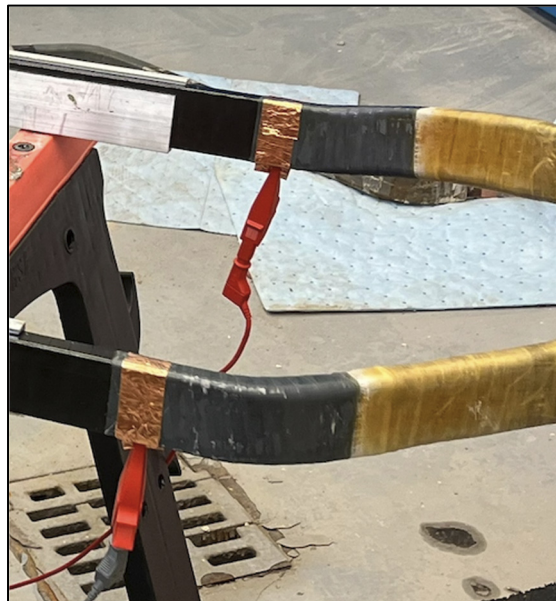
Figure 6.6 Picture of one of the guard electrodes installed on coil 07

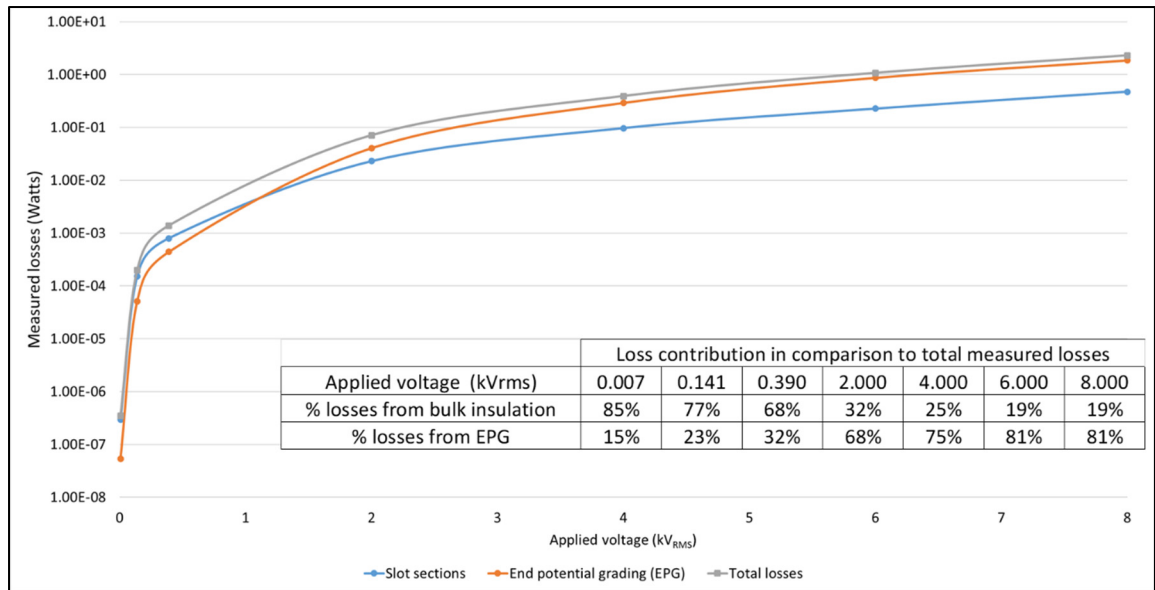
Figure 6.7 Guarded measured losses of the slot sections and the EPG sections

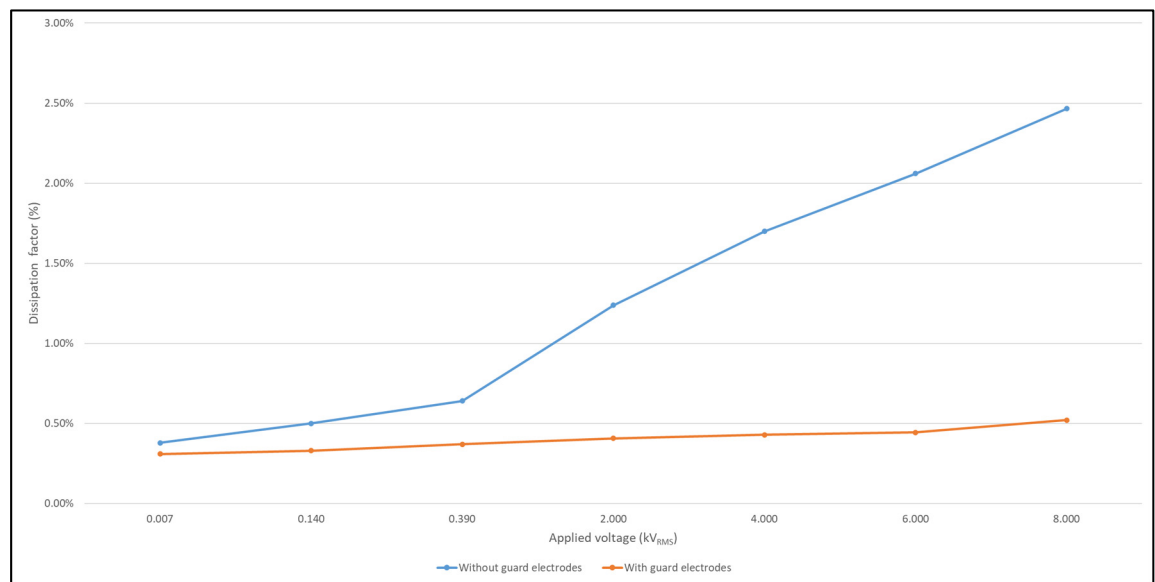
Figure 6.8 Comparison of DF measurements when performed with and without temporarily installed guard electrodes

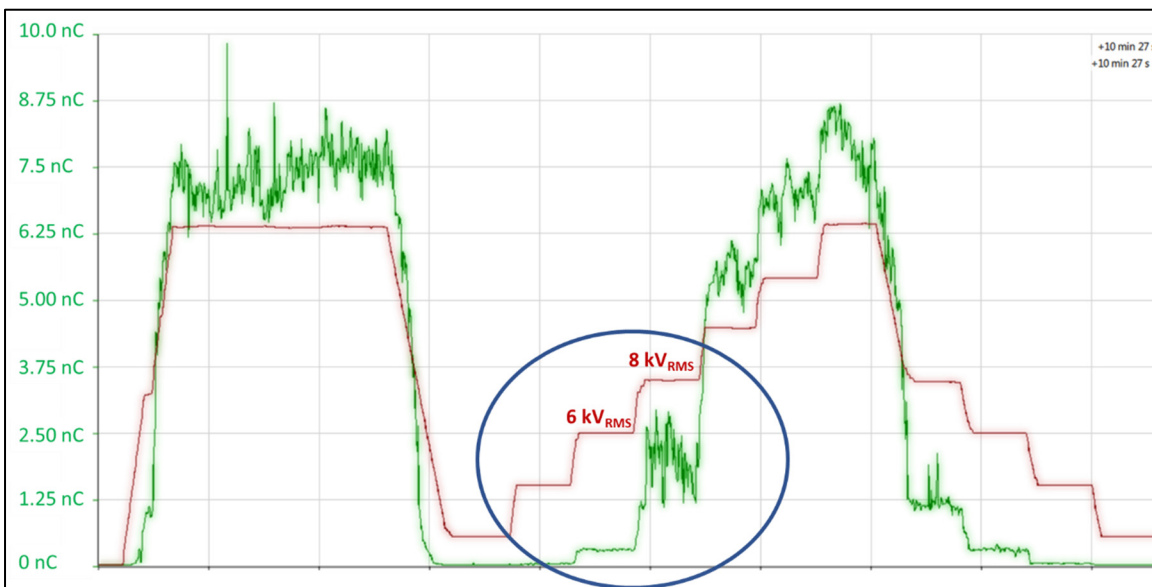
Figure 6.9 Measured apparent charge on coil 07 after 589 hours of VET showing the significant increase in PD activities from 6 kV_{RMS} to 8 kV_{RMS}

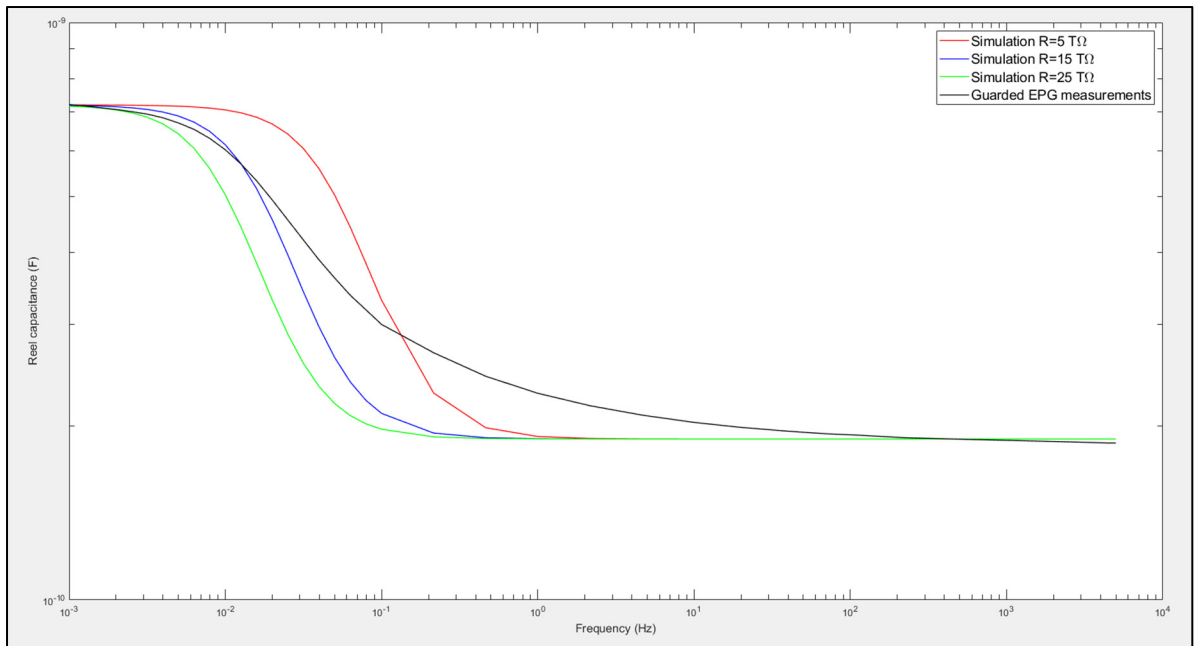
Figure 6.11 Simulated real capacitance of a simple R-C circuit using three different values of resistance of the EPG coating and, experimental results from a guarded measurement for coil 02

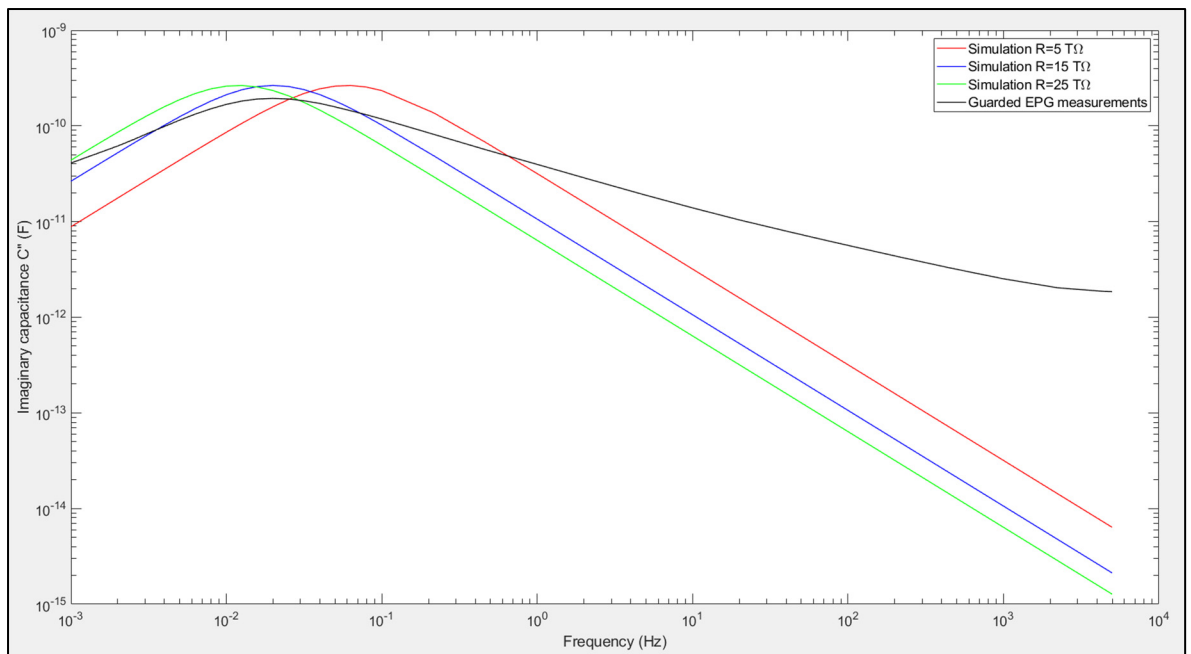
Figure 6.12 Simulated imaginary capacitance of a simple R-C circuit using three different values of resistance of the EPG coating and, experimental results from a guarded measurement for coil 02

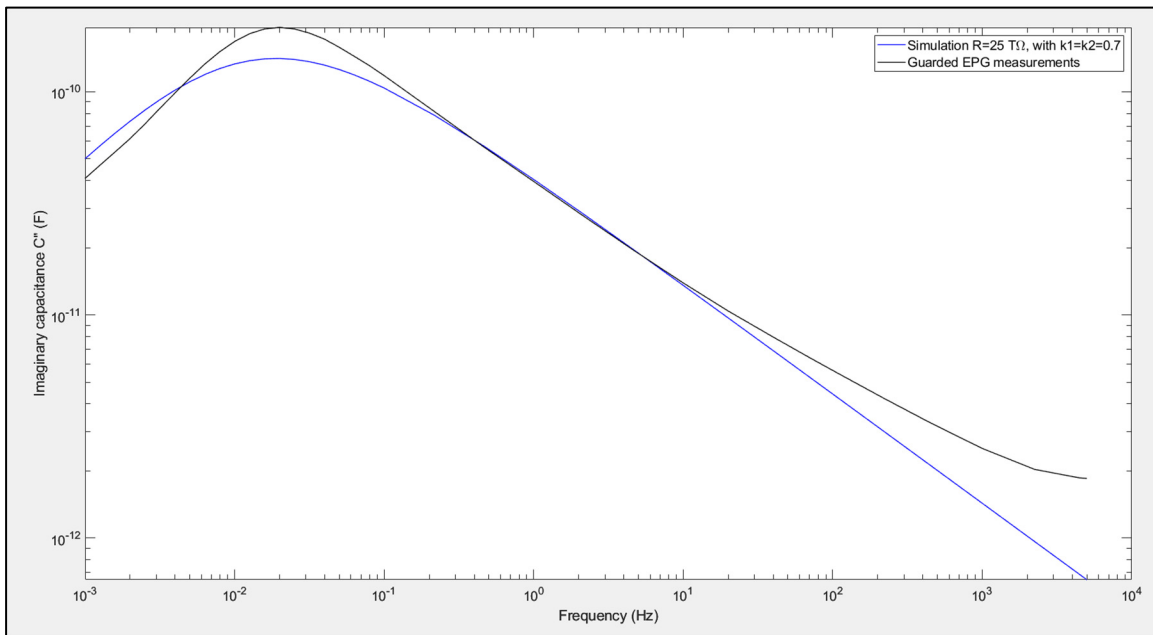
Figure 6.11 Simulated imaginary capacitance of a simple R-C with empirical parameters and, experimental results from a guarded measurement for coil 02

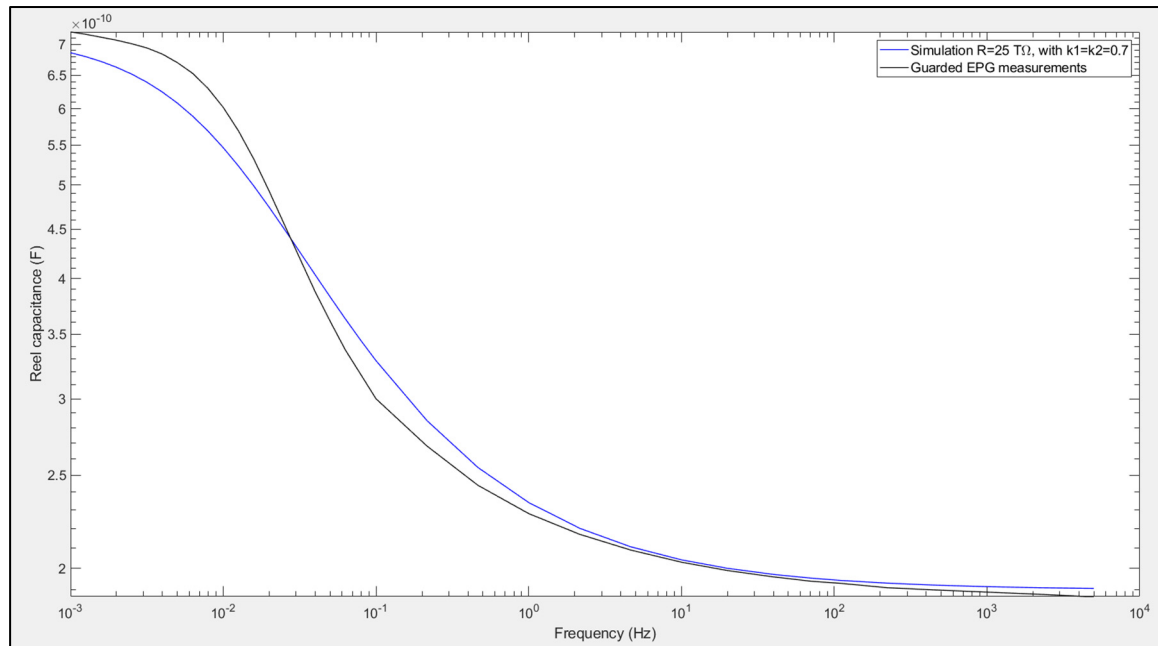
Figure 6.12 Simulated real capacitance of a simple R-C with empirical parameters and, experimental results from a guarded measurement for coil 02

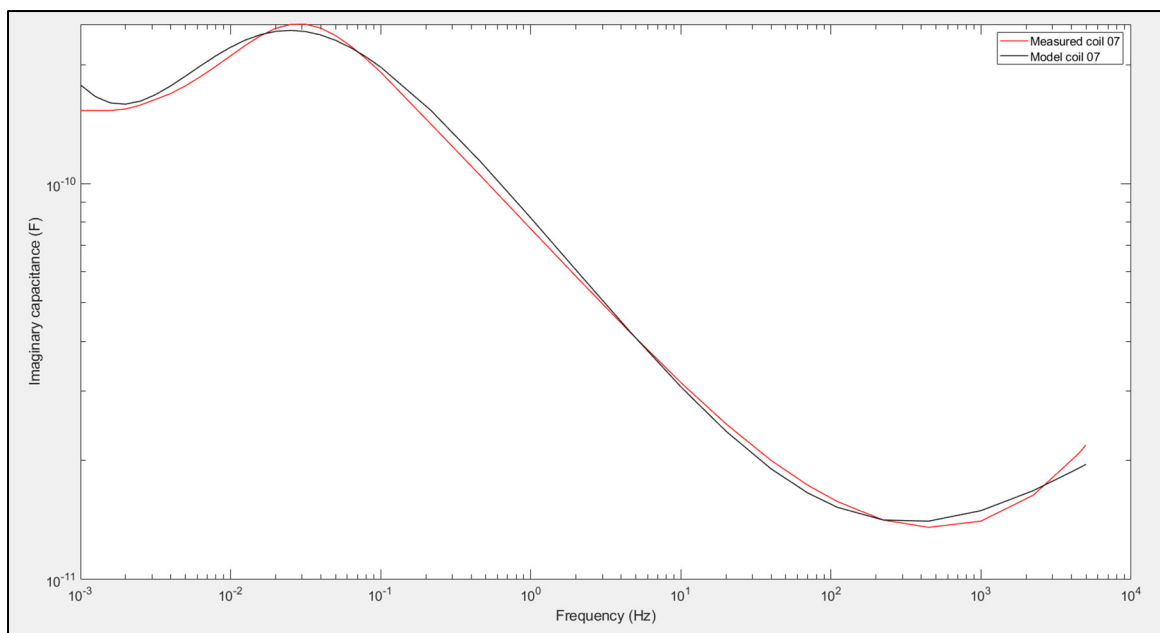
Figure 6.13 Simulated imaginary capacitance using the HN model compared with the measured imaginary capacitance of coil 07, after 208 hours of VET

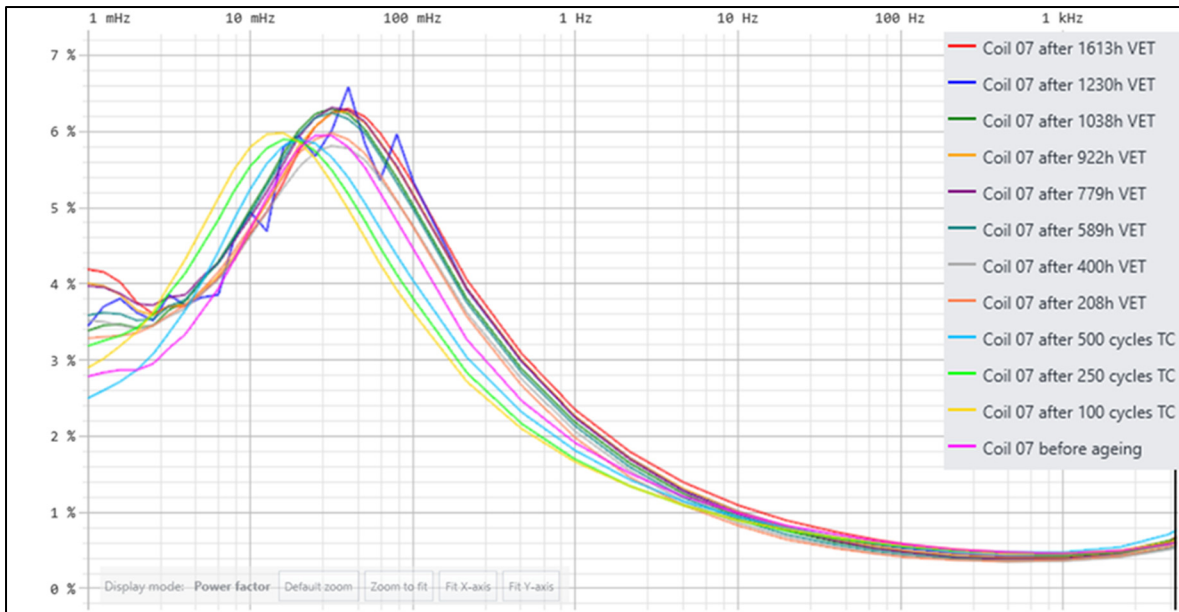
Figure 7.1 Power factor curves measured on coil 07 using a linear scaling for the y-axis

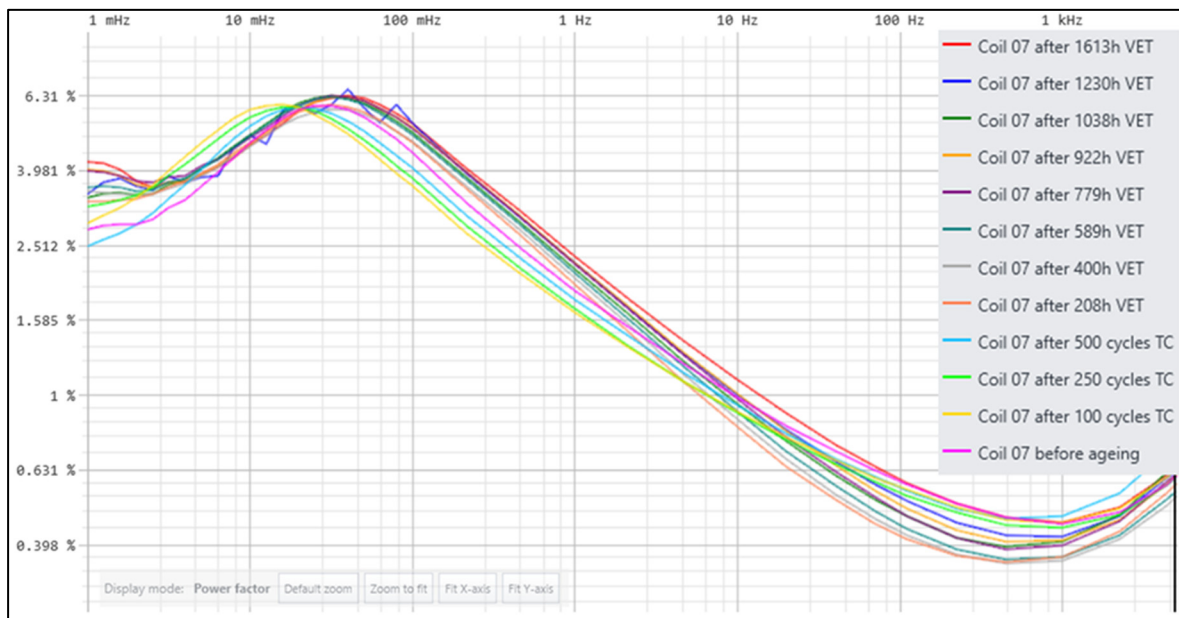
Figure 7.2 Power factor curves measured on coil 07 using a logarithmic scaling for the y-axis

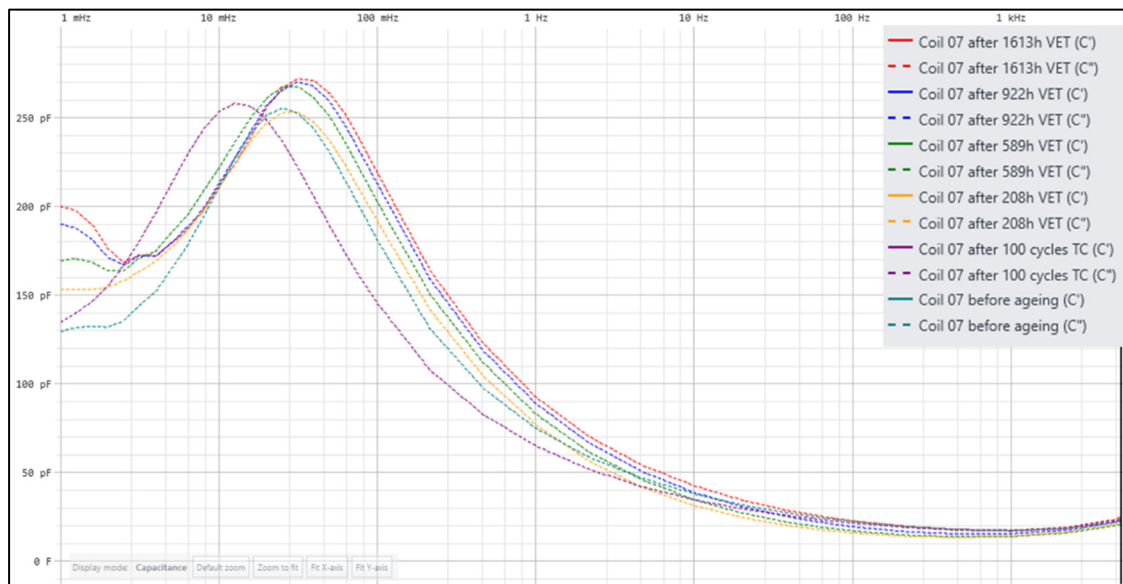
Figure 7.3 Summarized curves of the imaginary capacitance for coil 07

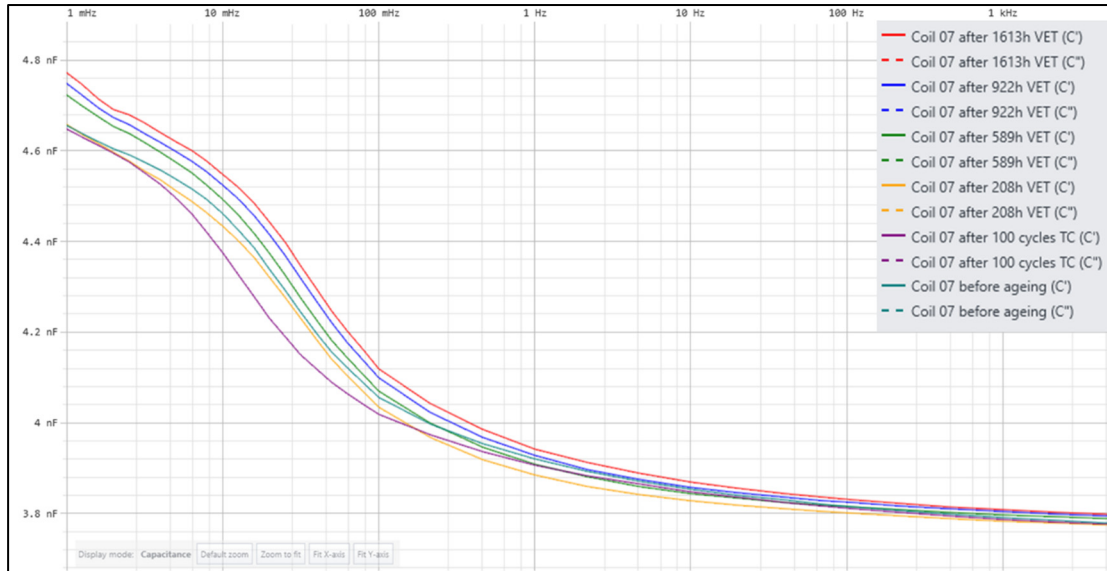
Figure 7.4 Summarized curves of the real capacitance for coil 07

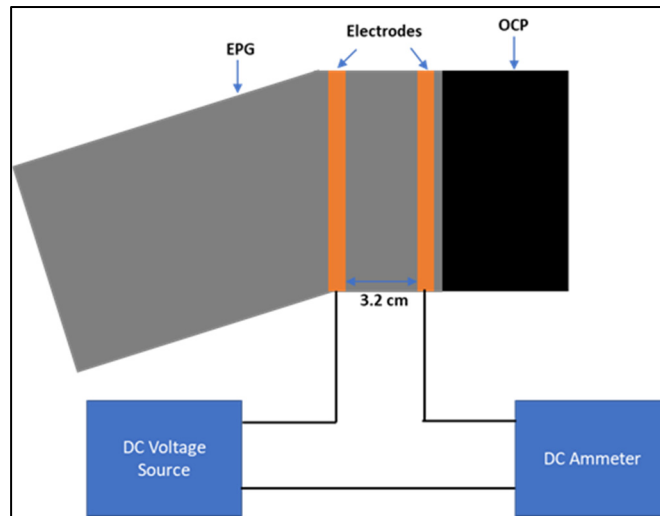
Figure 7.5 Schematic of the test setup for the measurements of the resistivity of the EPG coating

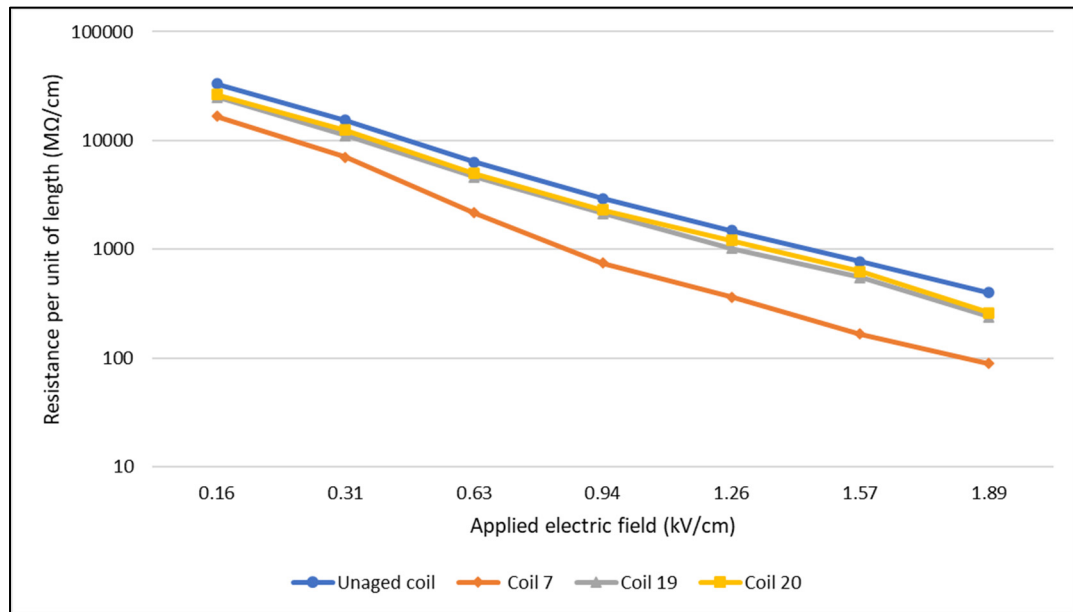
Figure 7.6 Measured resistance per unit of length of the EPG
