DIELECTRIC FREQUENCY RESPONSE ANALYSIS
APPLIED TO STATOR WINDING INSULATION
SYSTEMS

THESIS PRESENTED TO ÉCOLE DE TECHNOLOGIE SUPÉRIEURE
IN PARTIAL FULFILLMENT FOR A MASTER'S DEGREE
WITH THESIS IN ELECTRICAL ENGINEERING
M.A.Sc.

This study presents the results of investigations that were performed to verify if the use of low-voltage dielectric frequency response analysis can be successfully applied to detect the deterioration of stator winding insulation systems.

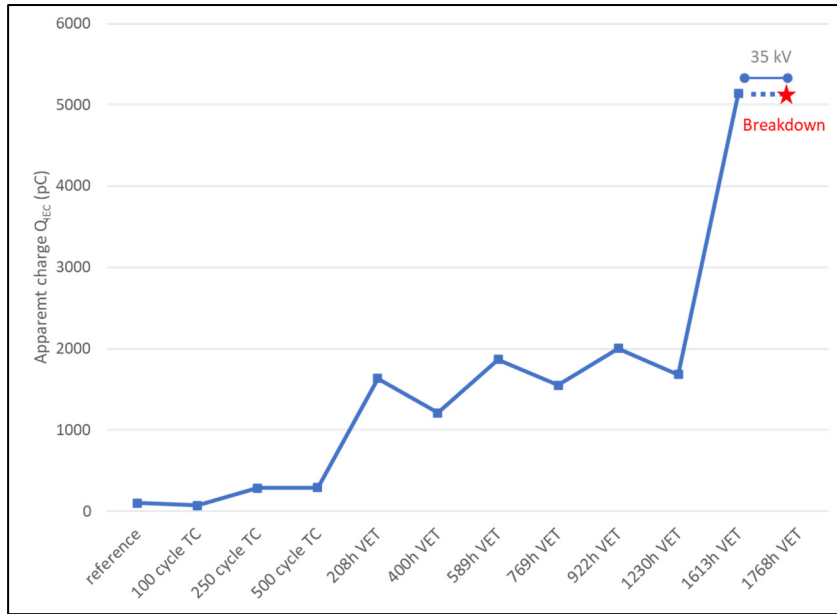
Figure 7.7 Trend of the measured apparent charge for coil 07

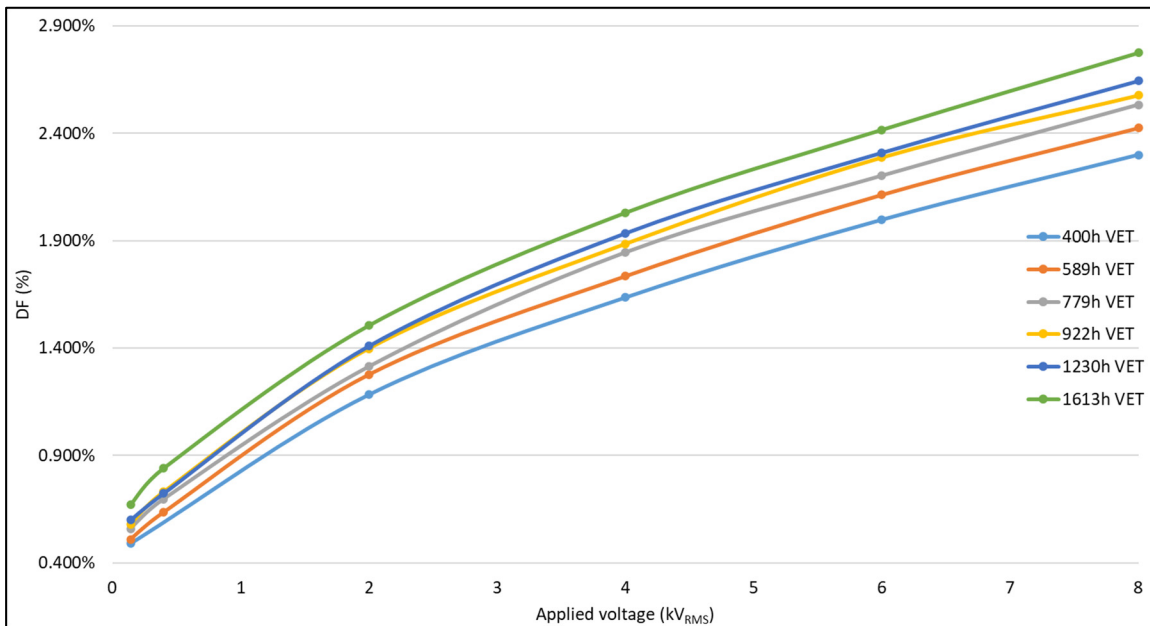
Figure 7.8 Measured DF measurements at 60 Hz at different stages of the ageing process

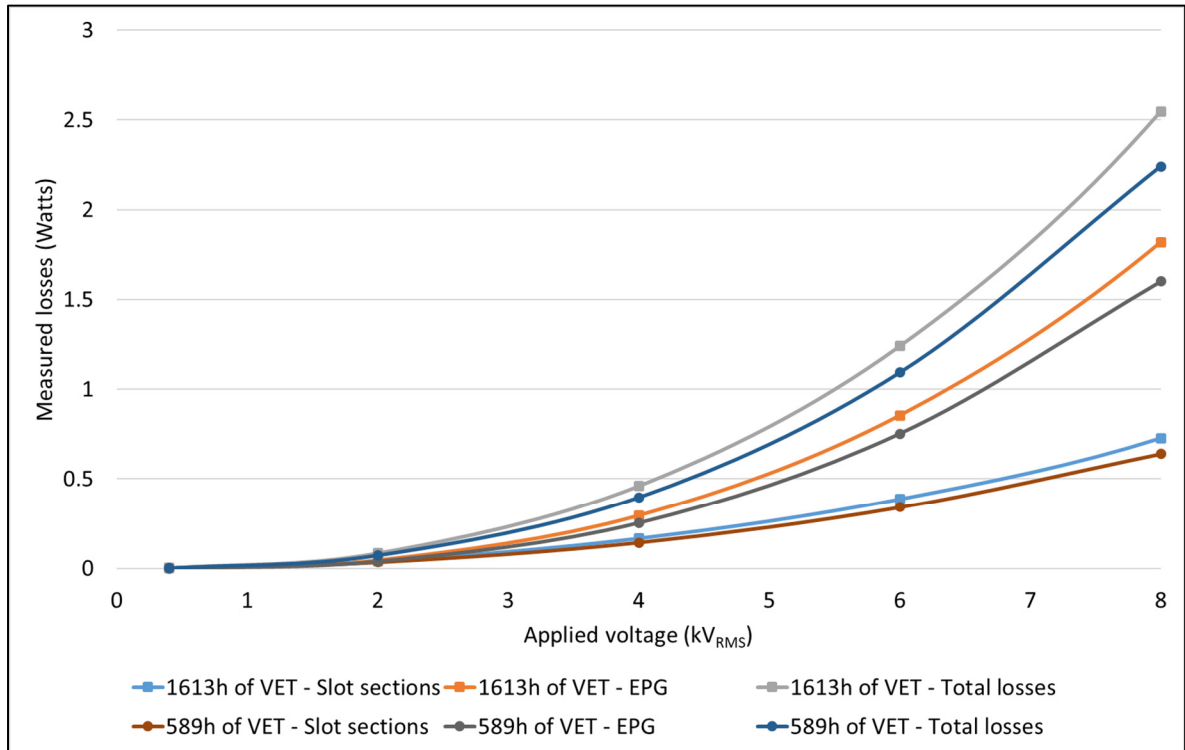
Figure 7.9 Results of guarded DF measurements after 589 hours and 1613 hours of ageing

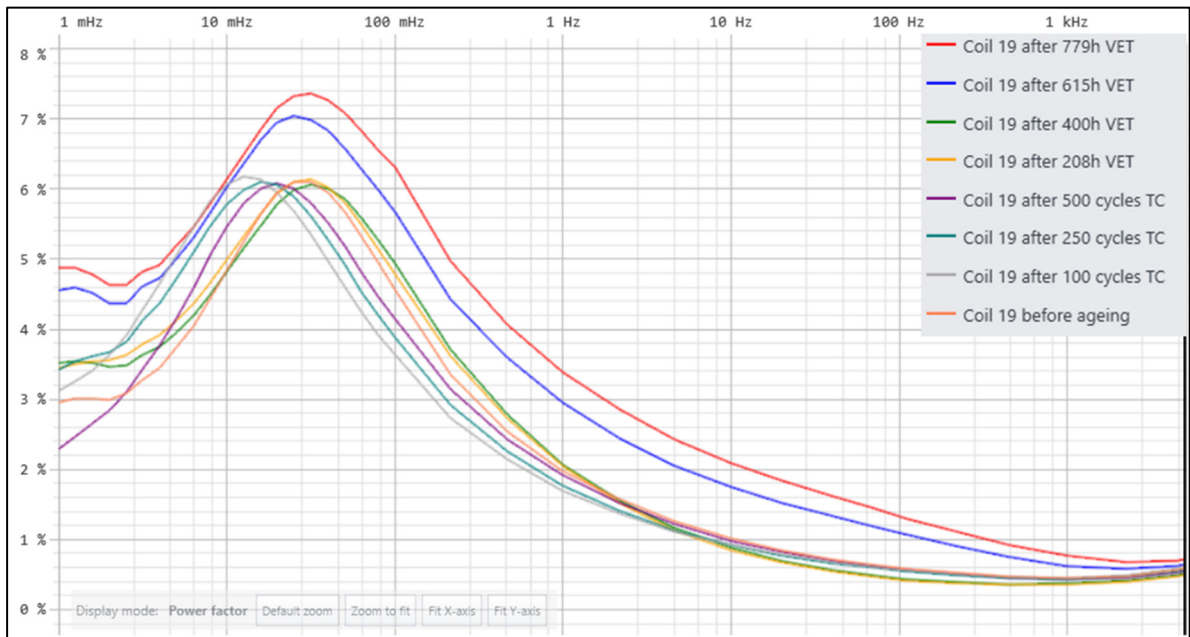
Figure 7.10 Power factor curves measured on coil 19 using a linear scaling for the y-axis

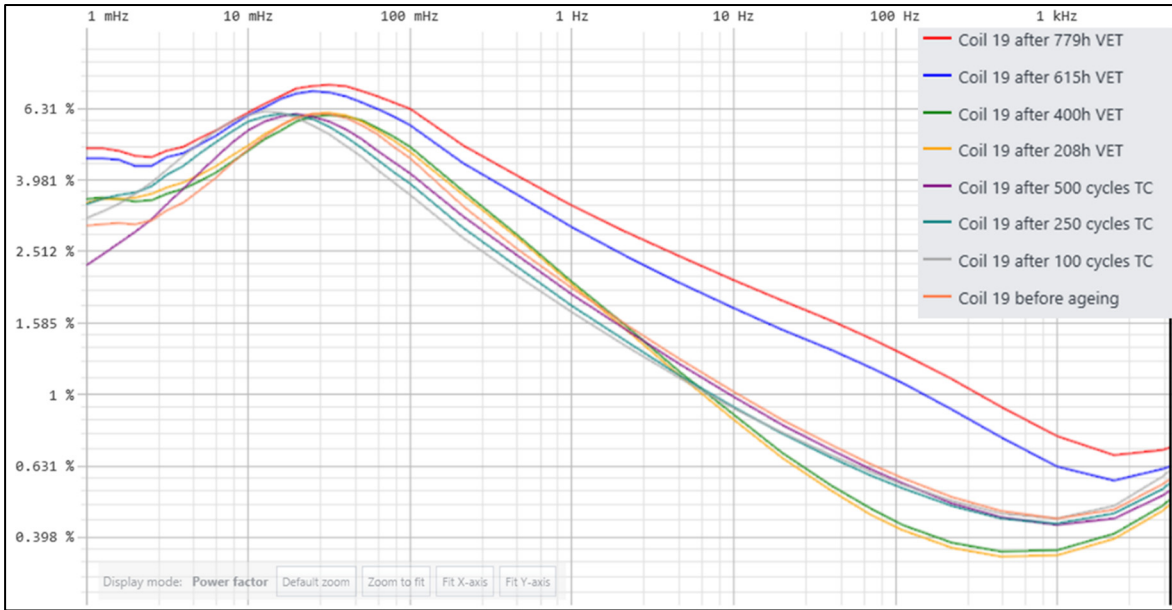
Figure 7.11 Power factor curves measured on coil 19 using a logarithmic scaling for the y-axis

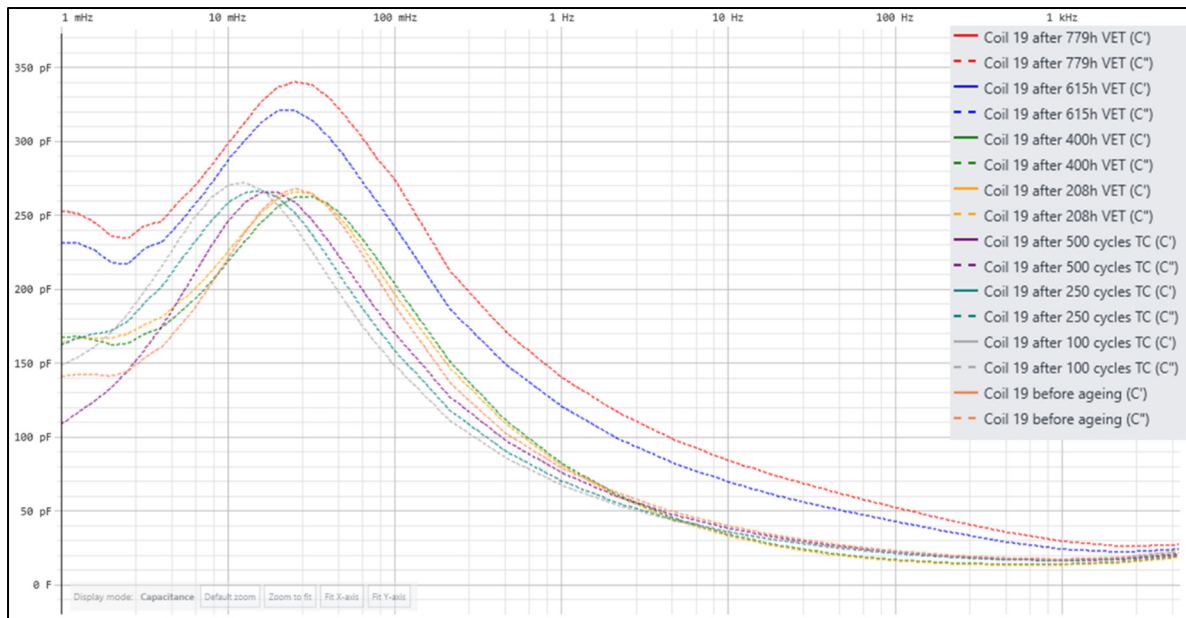
Figure 7.12 Measured imaginary capacitance curves on coil 19 displayed using a linear scaling for the y-axis

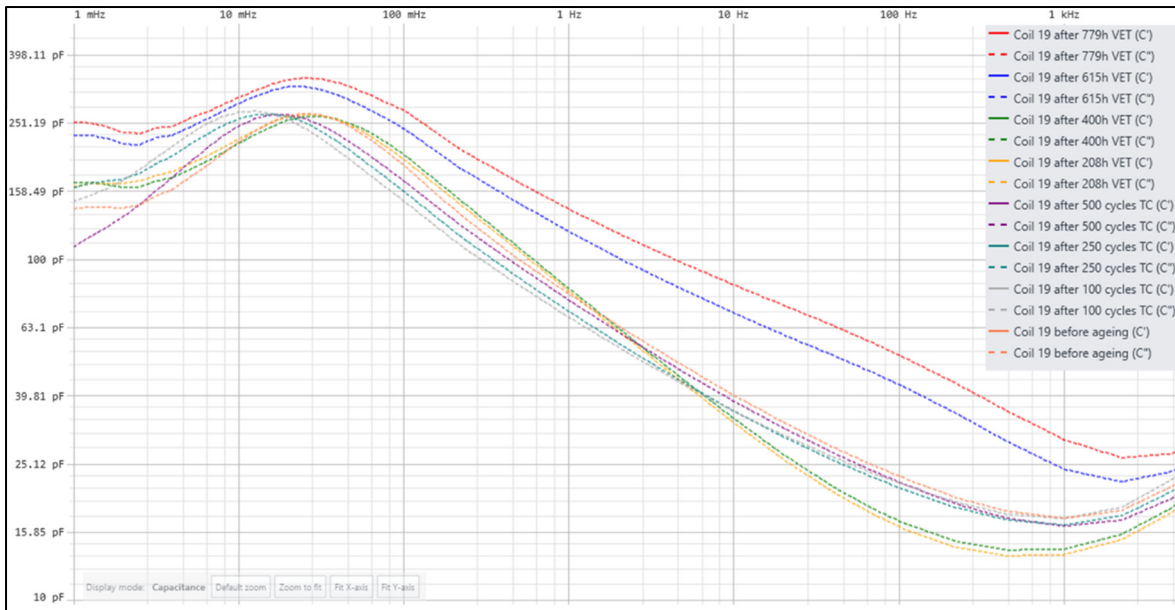
Figure 7.13 Measured imaginary capacitance curves on coil 19 displayed using a logarithmic scaling for the y-axis

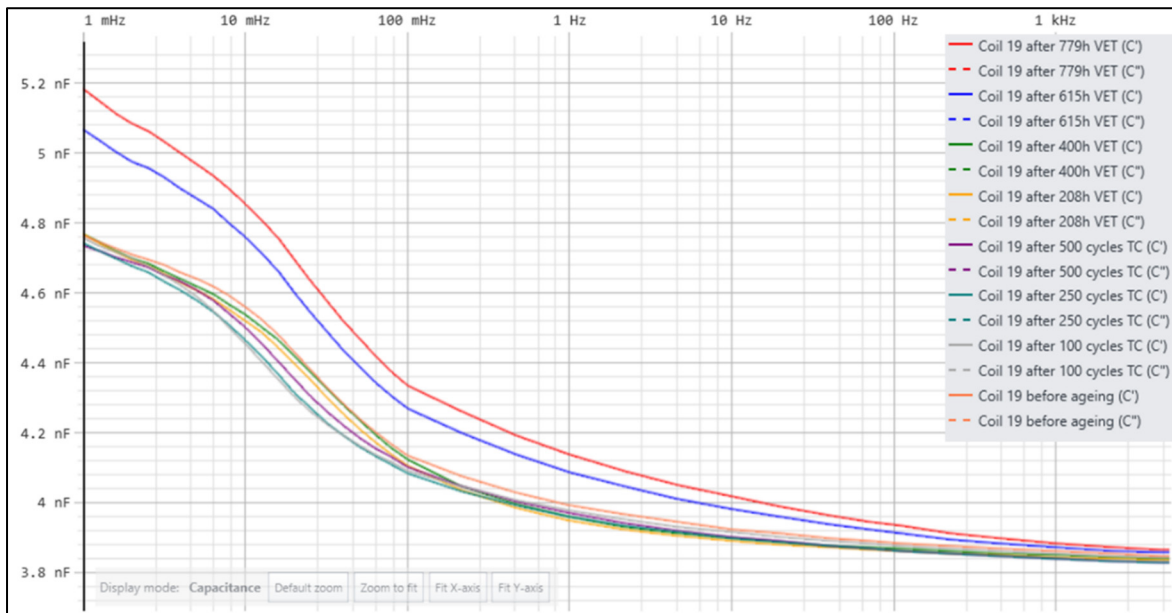
Figure 7.14 Measured real capacitance curves measured on coil 19

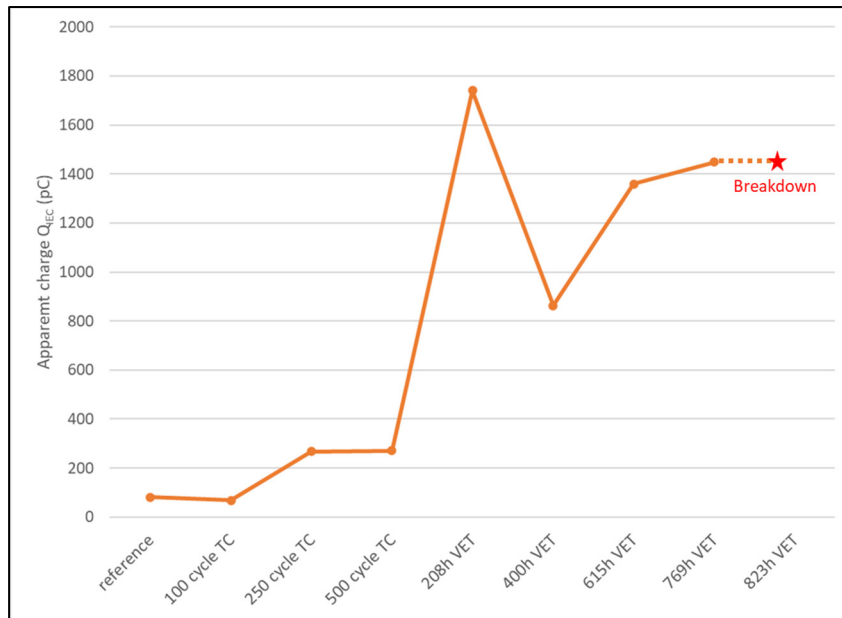
Figure 7.15 Trend of the measured apparent charge for coil 19

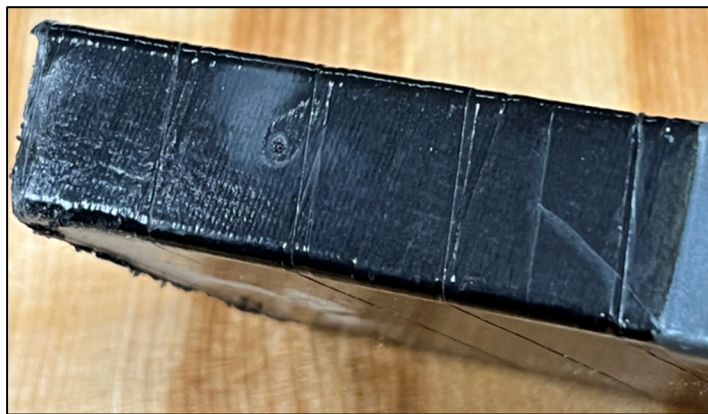
Figure 7.16 Picture of the suspect fault area of coil 19

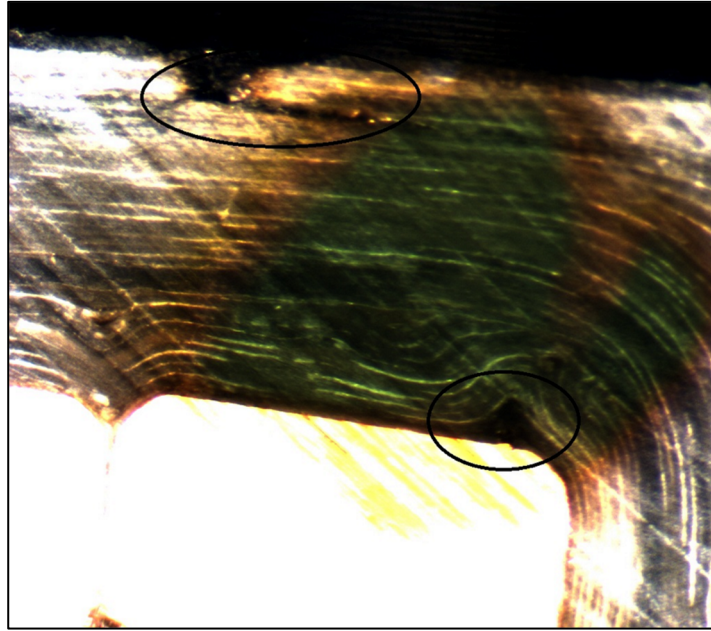
Figure 7.17 Picture of the cross-sectional cut in the suspected fault area using a stereoscope

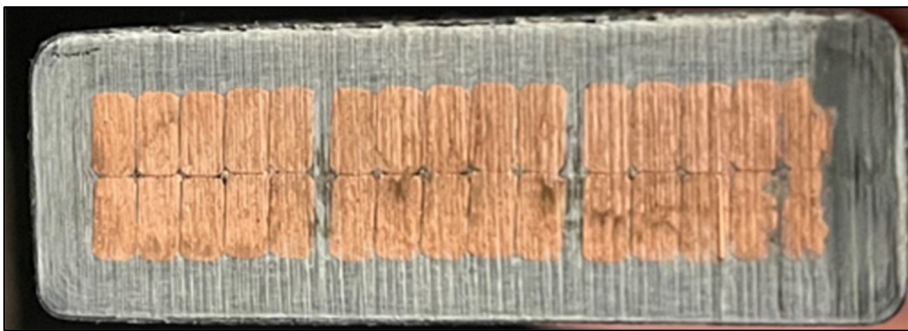
Figure 7.18 Cross-sectional cut of an unaged coil

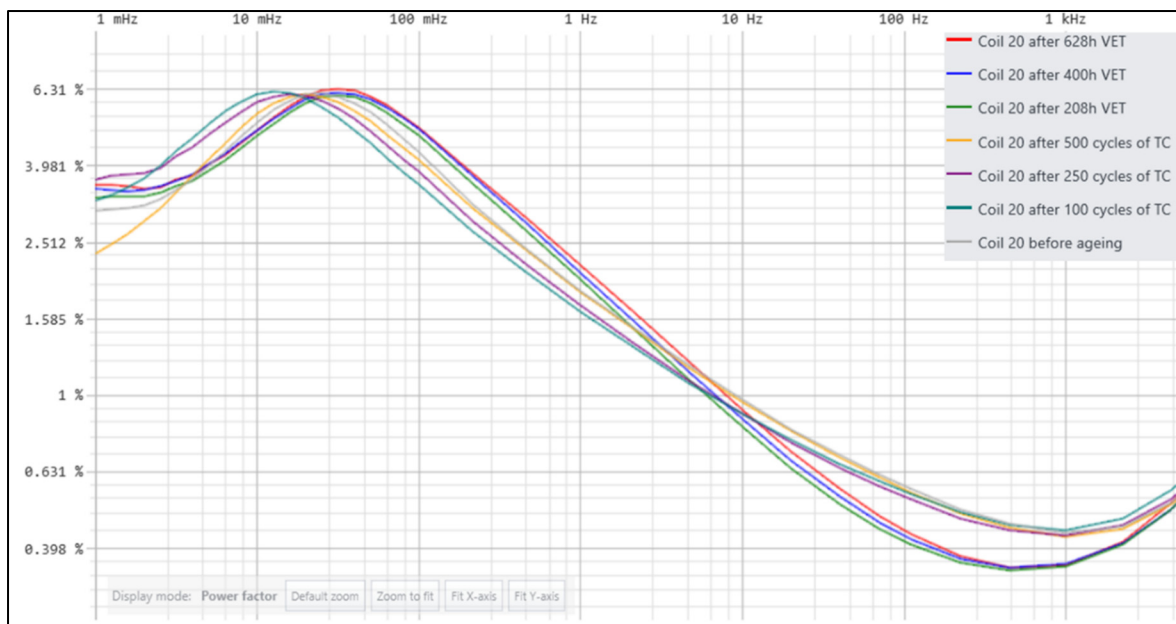
Figure 7.19 Power factor curves measured on coil 20 using a logarithmic scaling for the y-axis

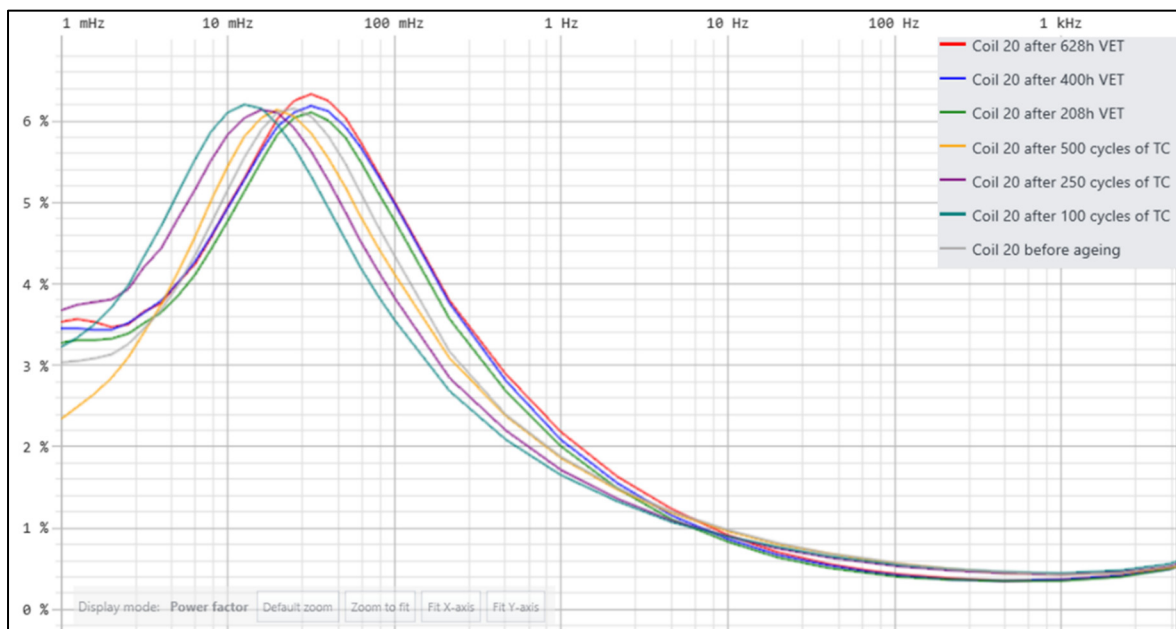
Figure 7.20 Power factor curves measured on coil 20 using a linear scaling for the y-axis

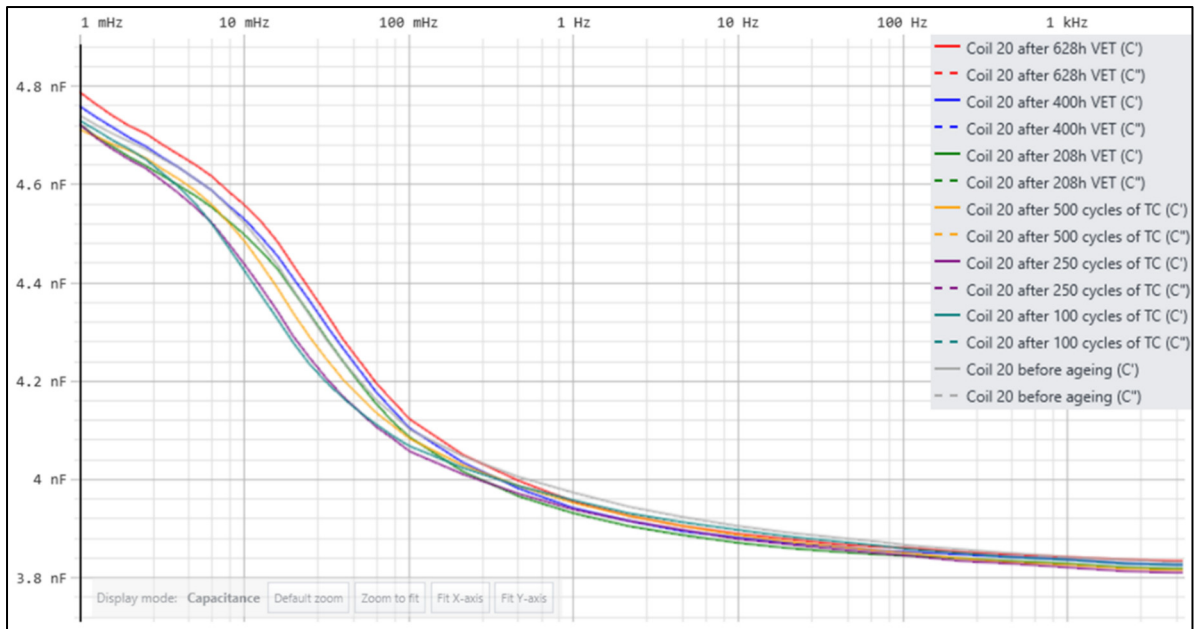
Figure 7.21 Measured real capacitance curves on coil 20

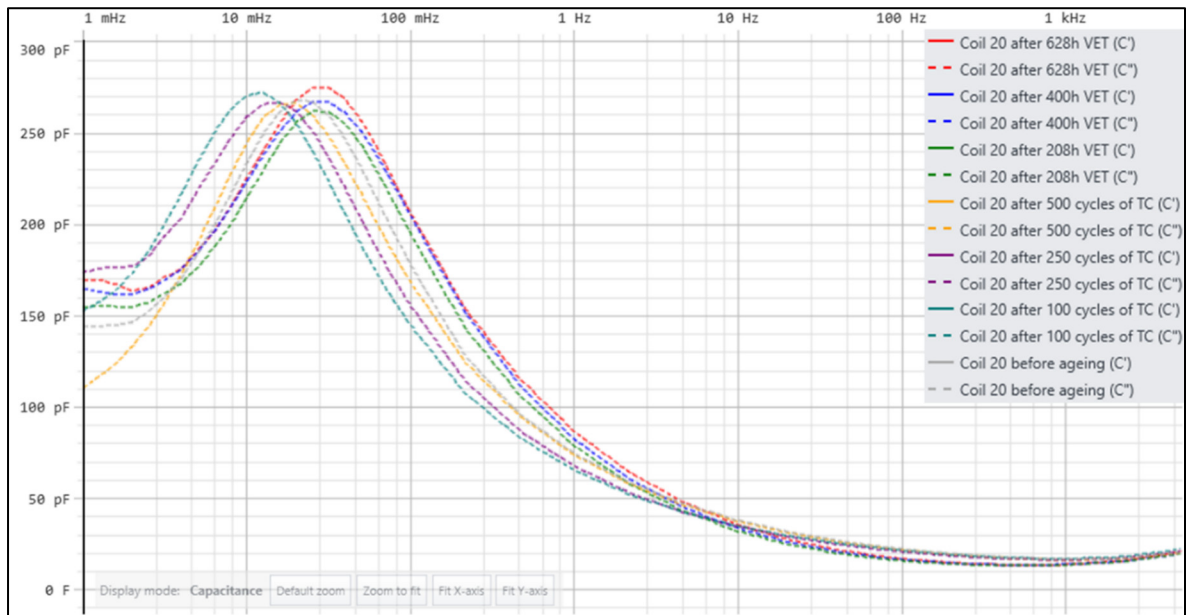
Figure 7.22 Measured imaginary capacitance curves on coil 20

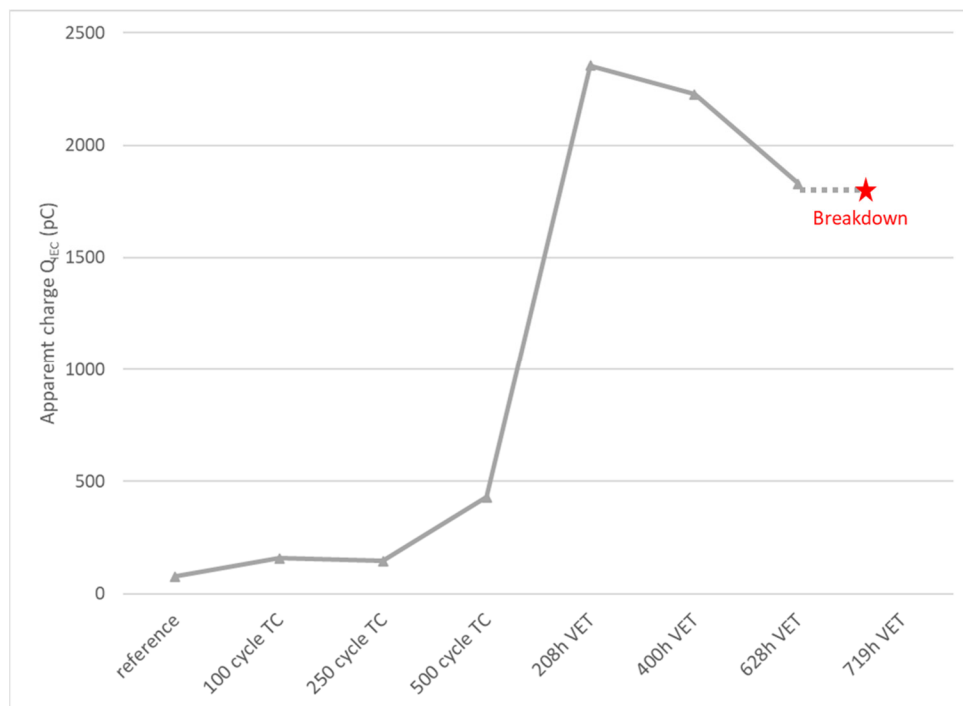
Figure 7.23 Trend of the measured apparent charge for coil 20

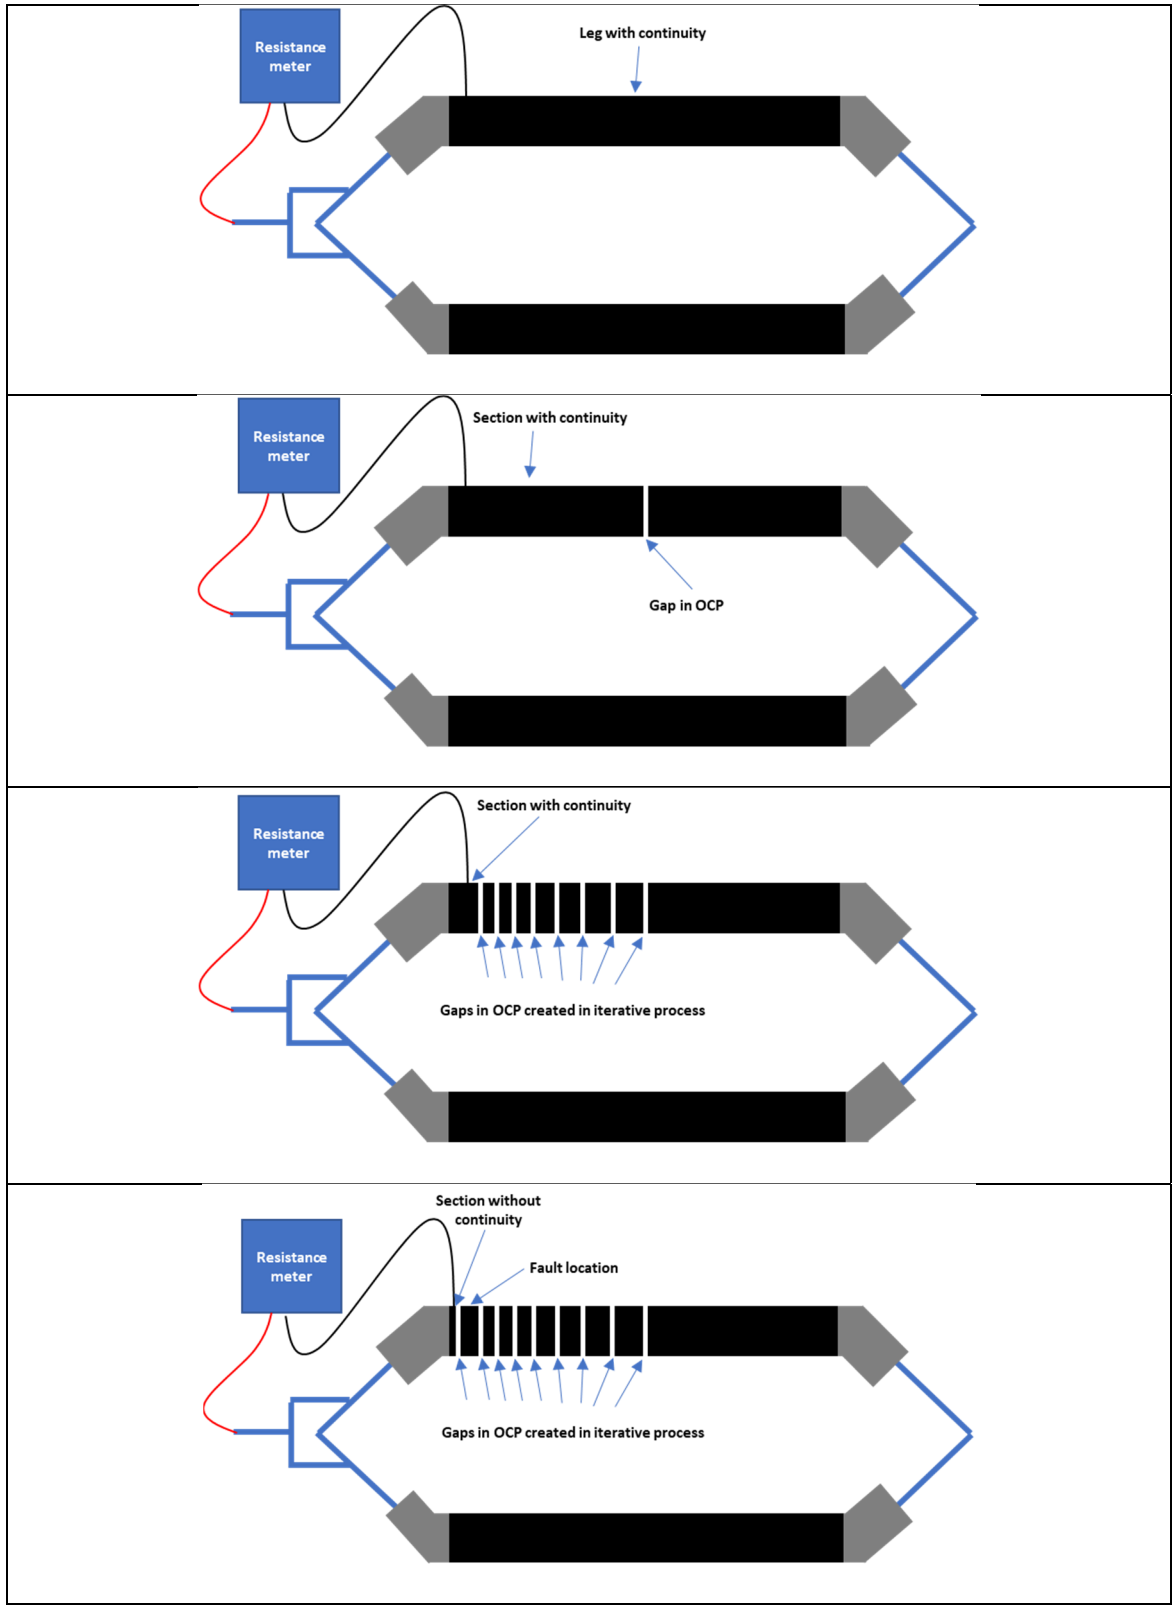
Figure 7.24 Sketches summarizing the process for localization of the fault

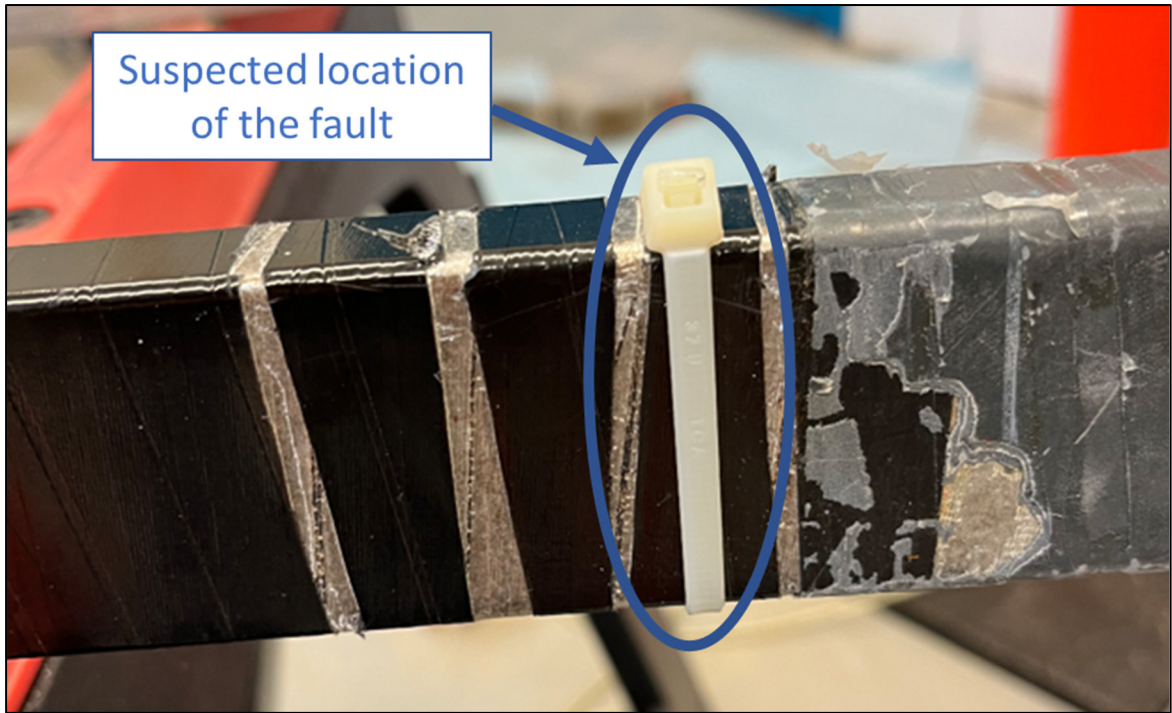
Figure 7.25 Picture of the suspected fault area

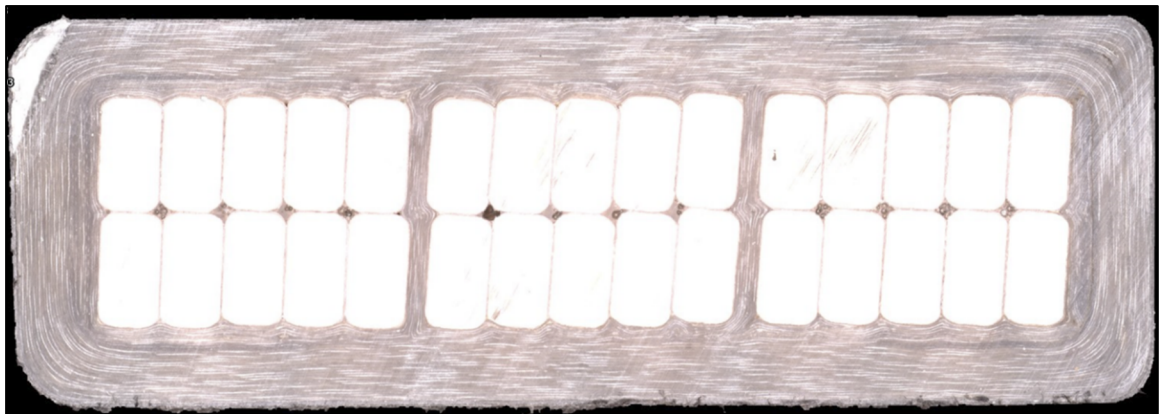
Figure 7.26 Picture of the cross-sectional cut in the suspected fault area using a microscope

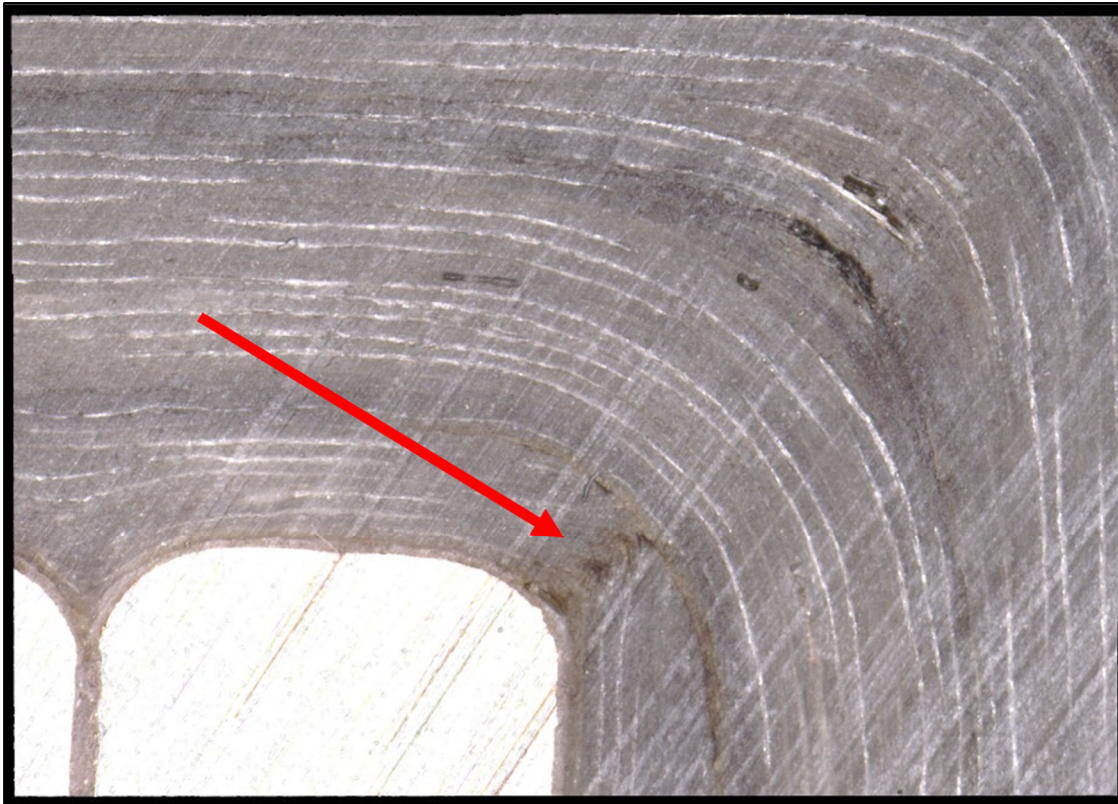
Figure 7.27 Picture of the upper right corner of figure 7.26

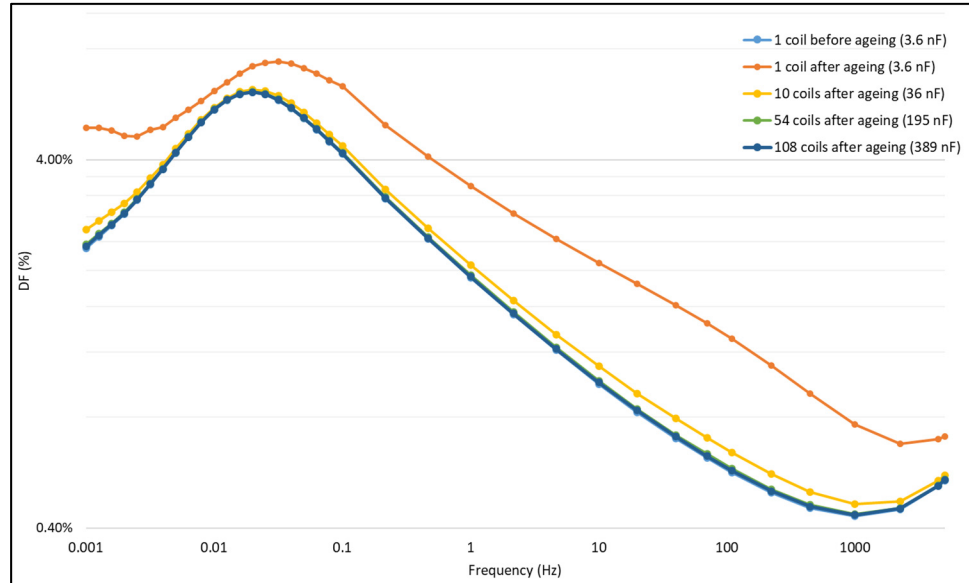
Figure 8.1 Projected DFR curves of coil 19 with different capacitance values

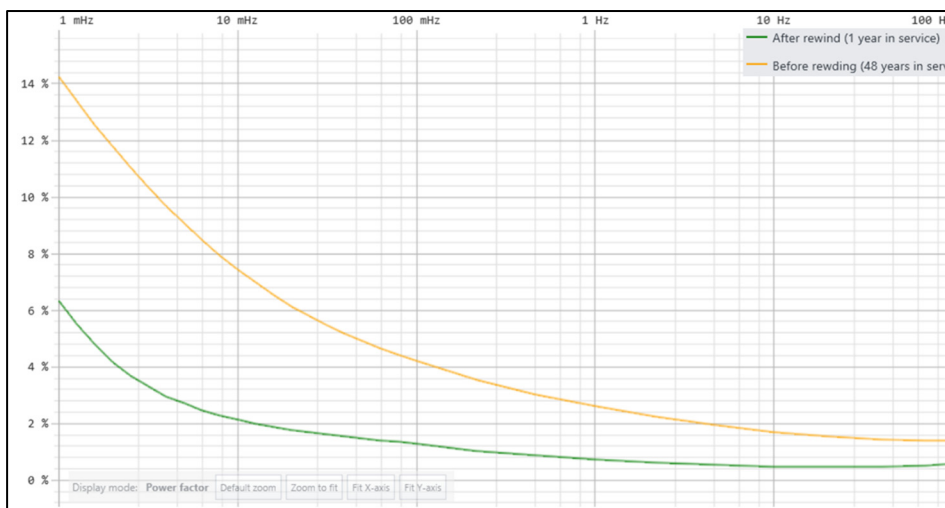
Figure 8.2 DFR curves from measurements performed on a 172 MVA hydro generator

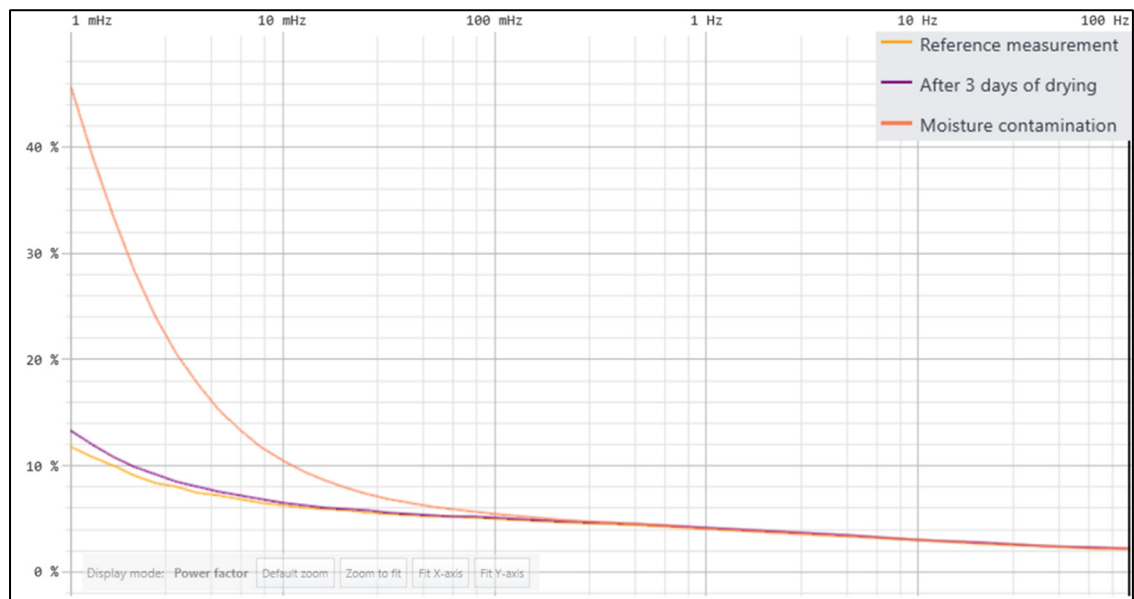
Figure 8.3 DFR curves from measurements performed on a 16 kV turbo generator
